## Access Compliance Report Public Rights-of-Way (Curb Ramps)

Intersection ID: N/A
 Main Street: ASCENSION\_WY
 Cross Street: HORACE\_ST
 Location:
 W

ADA ID: E47FBA16E6BC
 Ramp Type: Perp
 Initial Pass/Fail: Fail
 Overall Compliance: No
 Severity Score: 12.5

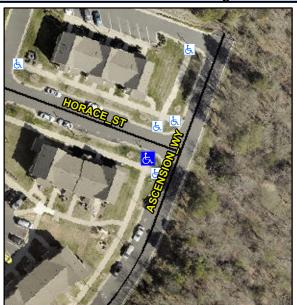
Compliance Description		Data	Comp	liance	Description	Data
N/A	Ramp Length (in)	72.0	No	Ram	Slope (%)	9.1
Yes	Ramp Width (in)	70.0	Yes	Ram	XSlope (%)	1.4
N/A	Flare Type LT	N/A	N/A	Flare	Type RT	N/A
N/A	Flare Slope LT (%)	N/A	N/A	Flare	Slope RT (%)	N/A
N/A	Flare Traversable LT?	N/A	N/A	Flare	Traversable RT?	N/A
N/A	Landing Length (in)	N/A	N/A	DWS	Provided?	N/A
N/A	Landing Width (in)	N/A	N/A	DWS	Contrast?	N/A
N/A	Landing Slope (%)	N/A	N/A	DWS	Length (in)	N/A
N/A	Landing X Slope (%)	N/A	N/A	DWS	Full Width?	N/A
N/A	Landing Curb? (Y/N)	N/A	N/A	DWS	Offset (in)	N/A
N/A	Shared Landing?	N/A				
N/A	Gutter Ponding?	N/A	N/A	Gutte	r Slope (%)	N/A
N/A	Gutter Lip Ht (in)	N/A	N/A	Gutte	er X Slope (%)	N/A
N/A	Painted X Walk1?	No	N/A	Paint	ed X Walk2?	N/A
	X Walk 1 Direction	To NE		X Wa	lk 2 Direction	N/A
N/A	X Walk 1 Width (in)	N/A	N/A	X Wa	lk 2 Width (in)	N/A
	X Walk 1 Slope (%)	1.9		X Wa	lk 2 Slope (%)	N/A
	X Walk 1 X Slope (%)	1.5		X Wa	lk 2 X Slope (%)	N/A

r.	Possible Solutions:
-	Remove & Replace Entire Ramp.
200	
200	
	Surveyor Notes:
V.	N/A
100	
S. L.	
1	PROW/ADA:
1000	R304.2.2
3	
雄

Total Cost:	\$ 1850.00
