Access Compliance Report Public Rights-of-Way (Curb Ramps)

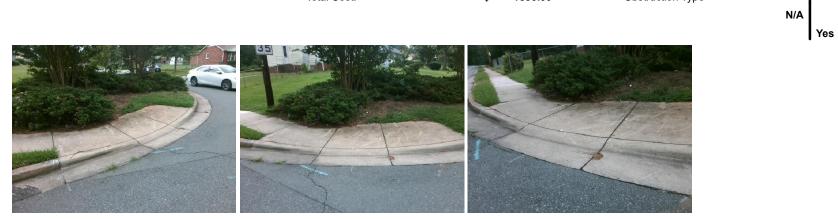
Intersection ID: 7240	Main Str	Main Street: MONTEITH_DR			TOM_HUNTER_RD	Location:	SE		
ADA ID: E486266B1E0D	Ramp Ty	Ramp Type: Perp			Initial Pass/Fail: Fail Overall Compliance: N			o Severity Score:	13.75
Codes/Mitigation Info/Possible Solution				Field Measurements/Component Compliance					
A CONTRACTOR OF THE OWNER		Possible Solutions:		Compliance Description D			ta Compliance Description Data		
and the second and	S Malan a 1	Remove & Replace Entire Ramp	-	N/A	Ramp Length (in)	59.5	No	Ramp Slope (%)	10.3
and the second second				Yes	Ramp Width (in)	48.0	No	Ramp XSlope (%)	3.2
	AR The			N/A	Flare Type LT	N/A	N/A	Flare Type RT	N/A
The second	ALL OF THE			N/A	Flare Slope LT (%)	N/A	N/A	Flare Slope RT (%)	N/A
	Mar and a start water			N/A	Flare Traversable LT?	N/A	N/A	Flare Traversable RT?	N/A
TON HUNTER RD				N/A	Landing Length (in)	N/A	N/A	DWS Provided?	N/A
Volta	- ANTRA C	Surveyor Notes:		N/A	Landing Width (in)	N/A	N/A	DWS Contrast?	N/A

P.	Not Found, R304.2.2, R304.5.3		N/A	Gutter Lip Ht (in)	N/A	N/A	Gutter X Slope (%)	N/A
THE PART	11			N/A	Painted X Walk1?	No	N/A	Painted X Walk2?	N/A
	1 10				X Walk 1 Direction	To W		X Walk 2 Direction	N/A
	6			N/A	X Walk 1 Width (in)	N/A	N/A	X Walk 2 Width (in)	N/A
Street 1 Name	MONTEITH DR	-			X Walk 1 Slope (%)	3.3		X Walk 2 Slope (%)	N/A
Stop Condition-Street 2	StopSign				X Walk 1 X Slope (%)	0.5		X Walk 2 X Slope (%)	N/A
Street 2 Name	. c N/A			N/A	Ramp inside XWalk1?	N/A	N/A	Ramp inside XWalk2?	N/A
Stop Condition-Street 1	N/A				Road Slope (%)	N/A	N/A	Clear Space?	N/A
					Road X Slope (%)	N/A	N/A	Clear Space to XWalk (in)	N/A
				N/A	Any Obstructions?	N/A	N/A	Storm Grate/Utility Hazard?	N/A
		Total Cost: \$	1850.00		Obstruction Type			Storm Grate/Utility Type	
					••	N/A			N/A
