# Access Compliance Report

## Public Rights-of-Way

### (Curb Ramps)

| Intersection ID: 50517 | Main Street: STEWART_TERRACE_WY | Cross Street: MICHAEL_CROSSING_DR | Location: S |

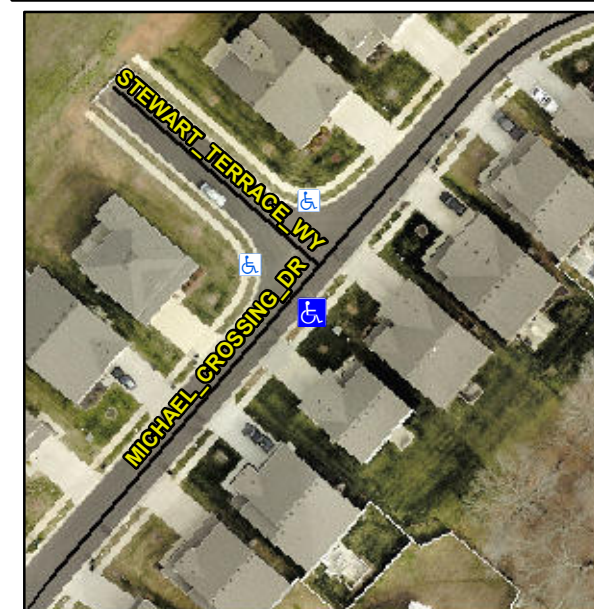
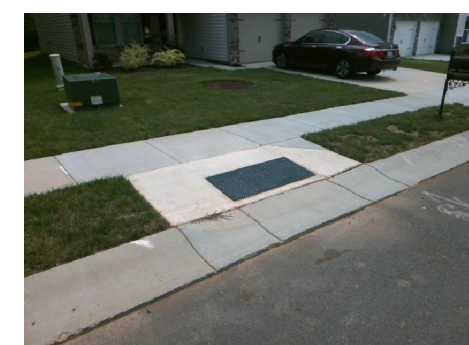
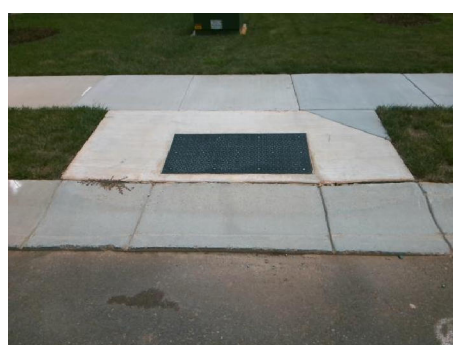
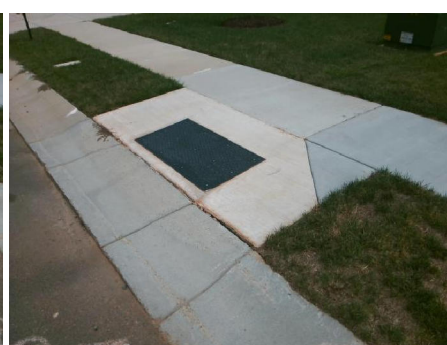
| ADA ID: E4882283FA6C | Ramp Type: Perp | Initial Pass/Fail: Fail | Overall Compliance: No |
| Severity Score: 12.5 | | | |

**Not Found, R304.2.2**

| Compliance | Description | Data | Compliance | Description | Data |
|---|---|---|---|---|---|
| N/A | Ramp Length (in) | 46.0 | No | Ramp Slope (%) | 10.6 |

**Remove & Replace Entire Ramp.**

Total Cost: \$ 1850.00
