Access Compliance Report

Public Rights-of-Way

(Curb Ramps)

| Intersection ID: 17513 | Main Street: PROVIDENCE_DR | Cross Street: PROVIDENCE_RD | Location: SE |

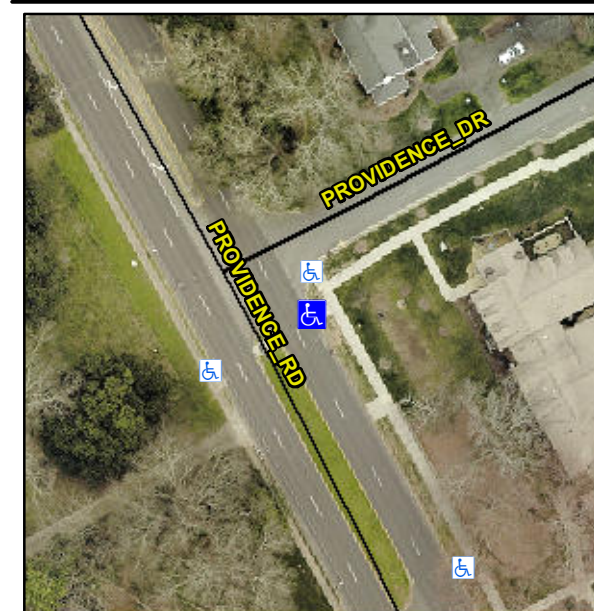
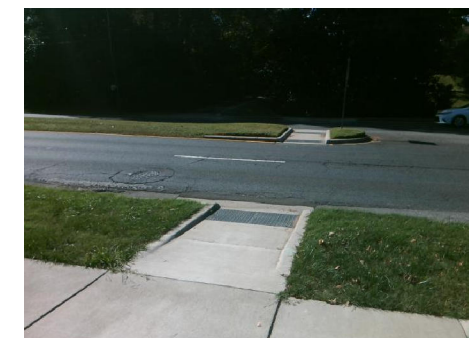
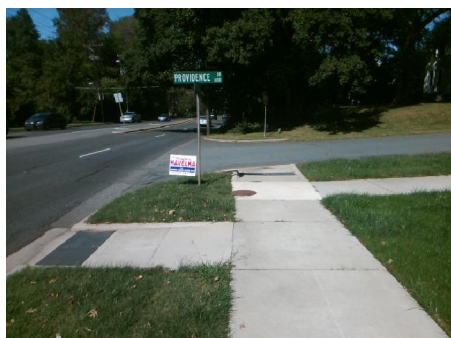
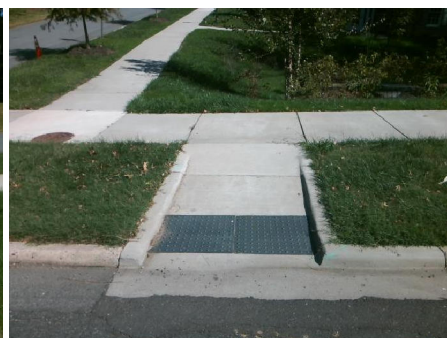
Not Found, R304.2.2

| Compliance | Description | Data | Compliance | Description | Data |
|---|---|---|---|---|---|
| N/A | Ramp Length (in) | 100.0 | No | Ramp Slope (%) | 8.6 |
| Yes | Ramp Width (in) | 58.0 | Yes | Ramp XSlope (%) | 1.5 |

Remove & Replace Entire Ramp.
