Access Compliance Report

Public Rights-of-Way

(Curb Ramps)

Intersection ID: 15131	Main Street: FILLMORE_AV	Cross Street: SCOTT_AV	Location: N
ADA ID: E4A42190E9EF	Ramp Type: Perp	Initial Pass/Fail: Fail	Overall Compliance: No
Severity Score: 13.75			
Codes/Mitigation Info/Possible Solution		Field Measurements/Component Compliance

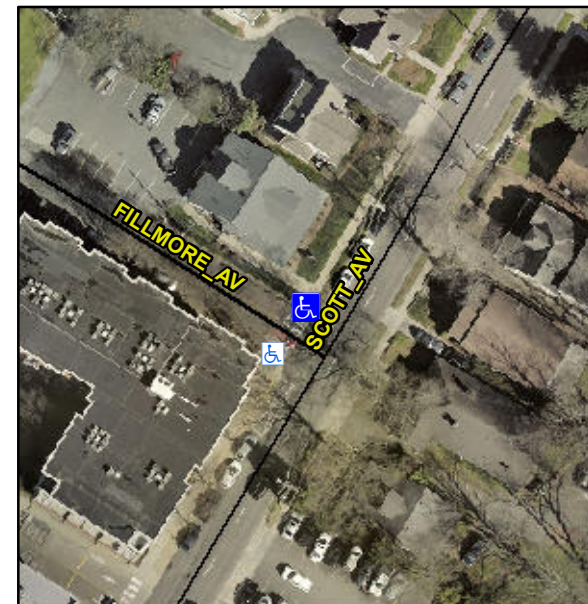
Not Found, R304.2.2, R304.5.3

Compliance	Description	Data	Compliance	Description	Data
N/A	Ramp Length (in)	66.0	No	Ramp Slope (%)	10.7
Yes	Ramp Width (in)	57.0	No	Ramp XSlope (%)	4.4
N/A	Flare Type LT	N/A	N/A	Flare Type RT	N/A
N/A	Flare Slope LT (%)	N/A	N/A	Flare Slope RT (%)	N/A
N/A	Flare Traversable LT?	N/A	N/A	Flare Traversable RT?	N/A
N/A	Landing Length (in)	N/A	N/A	DWS Provided?	N/A
N/A	Landing Width (in)	N/A	N/A	DWS Contrast?	N/A
N/A	Landing Slope (%)	N/A	N/A	DWS Length (in)	N/A
N/A	Landing X Slope (%)	N/A	N/A	DWS Full Width?	N/A
N/A	Landing Curb? (Y/N)	N/A	N/A	DWS Offset (in)	N/A
N/A	Shared Landing?	N/A			
N/A	Gutter Ponding?	Yes	N/A	Gutter Slope (%)	N/A
N/A	Gutter Lip Ht (in)	N/A	N/A	Gutter X Slope (%)	N/A
N/A	Painted X Walk1?	Yes	N/A	Painted X Walk2?	N/A
	X Walk 1 Direction	To SW		X Walk 2 Direction	N/A
N/A	X Walk 1 Width (in)	112.0	N/A	X Walk 2 Width (in)	N/A
	X Walk 1 Slope (%)	0.2		X Walk 2 Slope (%)	N/A
	X Walk 1 X Slope (%)	4.3		X Walk 2 X Slope (%)	N/A

Possible Solutions:

Remove & Replace Entire Ramp.

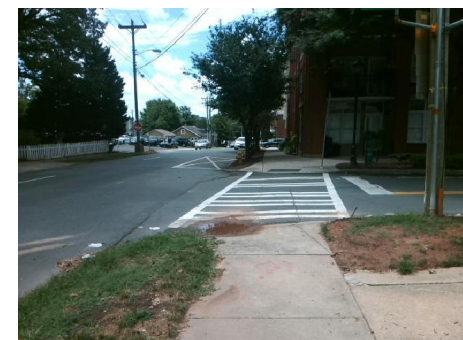
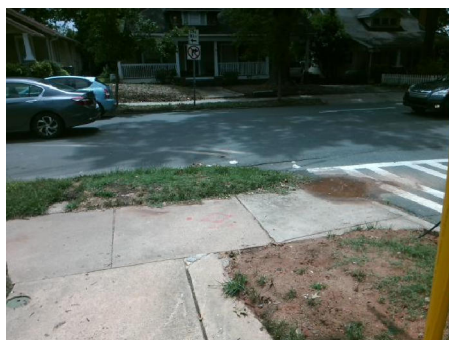
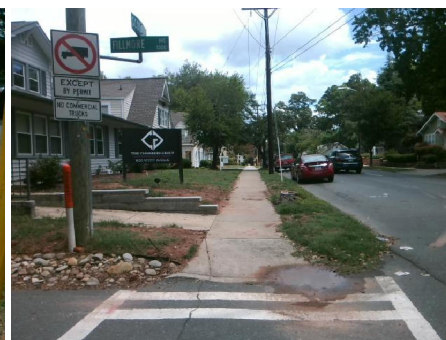
N/A	Ramp inside XWalk1?	Yes	N/A	Ramp inside XWalk2?	N/A
	Road Slope (%)	N/A	N/A	Clear Space?	N/A
	Road X Slope (%)	N/A	N/A	Clear Space to XWalk (in)	N/A
N/A	Any Obstructions?	N/A	N/A	Storm Grate/Utility Hazard?	N/A
	Obstruction Type			Storm Grate/Utility Type	
		N/A			N/A
		Yes		Surface Condition? (G/P)	Good
