Access Compliance Report

Public Rights-of-Way

(Curb Ramps)

Intersection ID: 11511	Main Street: E_18TH_ST	Cross Street: N_DAVIDSON_ST	Location: W
ADA ID: E4AF0E19B096	Ramp Type: PerpDiag	Initial Pass/Fail: Fail	Overall Compliance: No
		Severity Score: 25

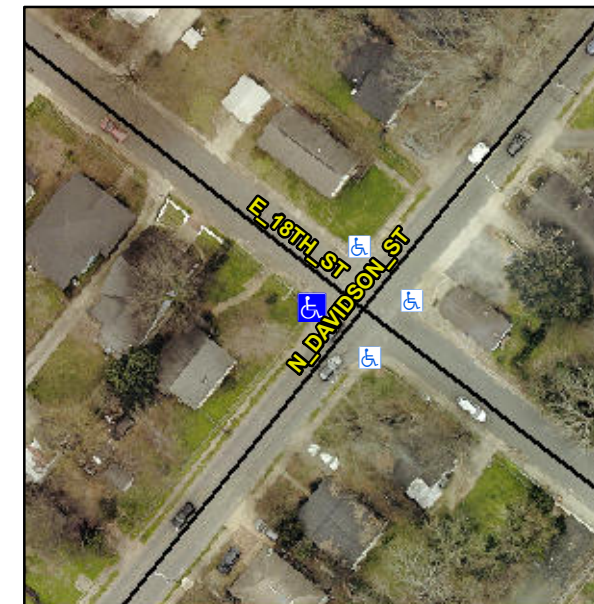
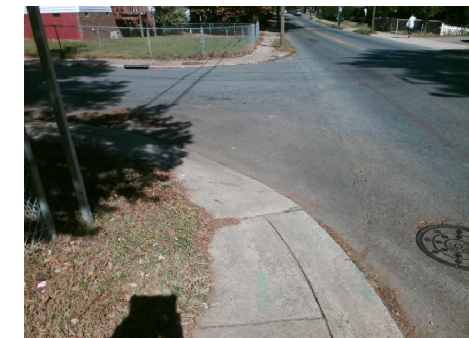
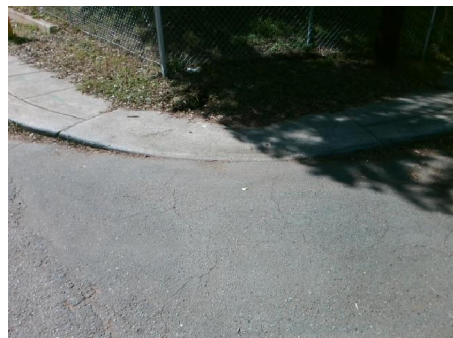
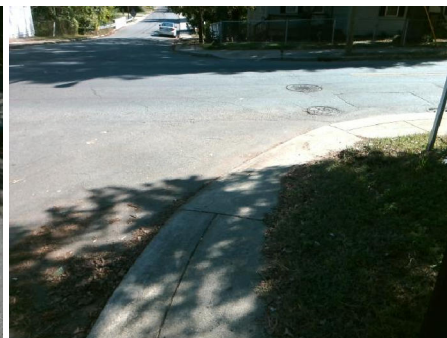
Not Found, R304.2.2

Compliance	Description	Data	Compliance	Description	Data
N/A	Ramp Length (in)	60.0	No	Ramp Slope (%)	14.8
Yes	Ramp Width (in)	50.0	Yes	Ramp XSlope (%)	1.5
N/A	Flare Type LT	N/A	N/A	Flare Type RT	N/A
N/A	Flare Slope LT (%)	N/A	N/A	Flare Slope RT (%)	N/A
N/A	Flare Traversable LT?	N/A	N/A	Flare Traversable RT?	N/A
N/A	Landing Length (in)	N/A	N/A	DWS Provided?	N/A
N/A	Landing Width (in)	N/A	N/A	DWS Contrast?	N/A
N/A	Landing Slope (%)	N/A	N/A	DWS Length (in)	N/A
N/A	Landing X Slope (%)	N/A	N/A	DWS Full Width?	N/A
N/A	Landing Curb? (Y/N)	N/A	N/A	DWS Offset (in)	N/A
N/A	Shared Landing?	N/A			
N/A	Gutter Ponding?	N/A	N/A	Gutter Slope (%)	N/A
N/A	Gutter Lip Ht (in)	N/A	N/A	Gutter X Slope (%)	N/A
N/A	Painted X Walk1?	No	N/A	Painted X Walk2?	No
	X Walk 1 Direction	To SE		X Walk 2 Direction	To NE
N/A	X Walk 1 Width (in)	N/A	N/A	X Walk 2 Width (in)	N/A
	X Walk 1 Slope (%)	2.3		X Walk 2 Slope (%)	0.3
	X Walk 1 X Slope (%)	1.1		X Walk 2 X Slope (%)	0.2

N/A	Ramp inside XWalk1?	N/A	N/A	Ramp inside XWalk2?	N/A
	Road Slope (%)	0.9	N/A	Clear Space?	N/A
	Road X Slope (%)	0.2	N/A	Clear Space to XWalk (in)	N/A
N/A	Any Obstructions?	N/A	N/A	Storm Grate/Utility Hazard?	N/A
	Obstruction Type			Storm Grate/Utility Type	
		N/A			N/A
		Yes		Surface Condition? (G/P)	Good

Remove & Replace Curb Ramp With Two New Directional Ramps or Equivalent.
