# Access Compliance Report

## Public Rights-of-Way

### (Curb Ramps)

| Intersection ID: 47836 | Main Street: ALVARADO_WY | Cross Street: DRAGONFLY_LN | Location: | E |

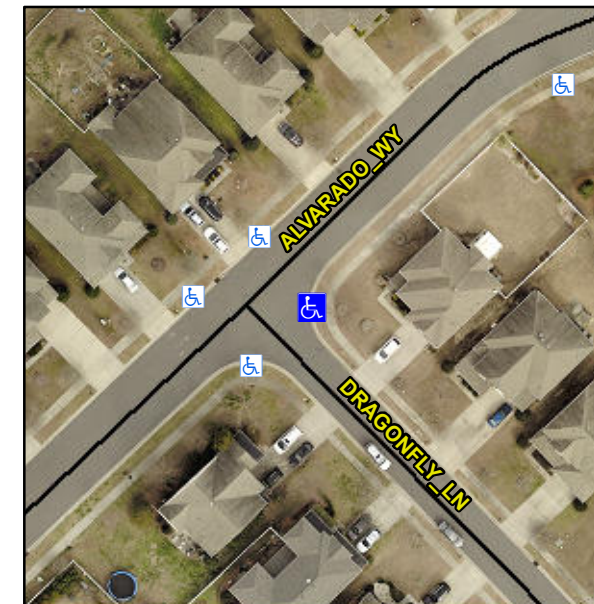
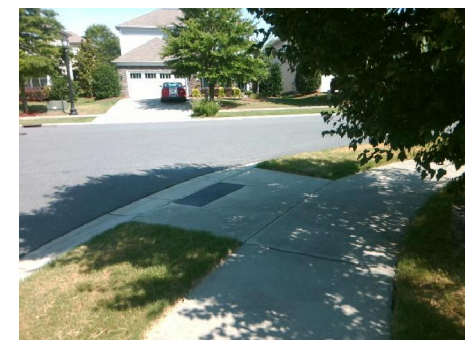
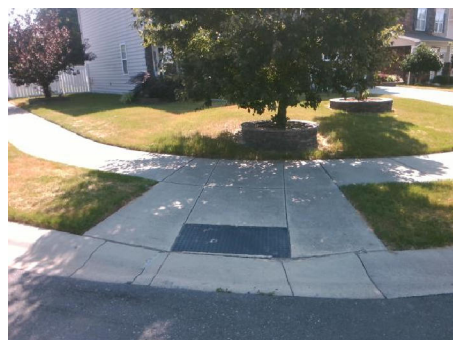
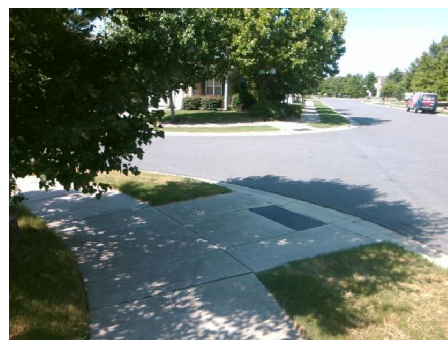
**NO LNDG**

**R304.5.1, R304.5.3**

| Compliance | Description | Data | Compliance | Description | Data |
|---|---|---|---|---|---|
| No | Ramp Width (in) | 44.0 | No | BlendTrans XSlope (%) | 4.2 |

**Remove & Replace Curb Ramp With Two New Directional Ramps or Equivalent.**
