# Access Compliance Report

## Public Rights-of-Way

### (Curb Ramps)

Intersection ID: 21451		Main Street: THORNCLIFF_DR		Cross Street: WOODSTREAM_DR		Location:		SE											
ADA ID: E4E3C4BEDC4D		Ramp Type: Directional1		Initial Pass/Fail: Fail		Overall Compliance: No		Severity Score: 10											
Codes/Mitigation Info/Possible Solution				Field Measurements/Component Compliance

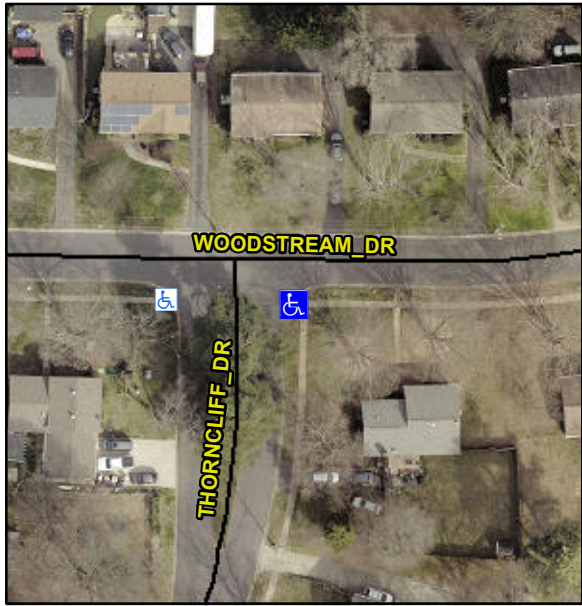
<div>Street 1 NameTHORNCLIFF DR</div> <div>Stop Condition-Street 1StopSign</div> <div>Street 2 NameN/A</div> <div>Stop Condition-Street 2N/A</div>				Possible Solutions:		Compliance		Description		Data		Compliance		Description		Data			
				Remove & Replace Entire Ramp.		N/A		Ramp Length (in)		24.0		N/A		Grade Break?		N/A		N/A	
						No		Ramp Width (in)		47.5		N/A		Grade Break Slope (%)		N/A		0.0	
						Yes		Ramp Slope (%)		1.7		N/A		Grade Break XSlope (%)		N/A		0.0	
						No		Ramp XSlope (%)		3.9									
						N/A		Flare Type LT		N/A		N/A		Flare Type RT		N/A		N/A	
						N/A		Flare Slope LT (%)		N/A		N/A		Flare Slope RT (%)		N/A		0.0

N/A		Flare Traversable LT?		N/A		N/A		Flare Traversable RT?		N/A		N/A	
						N/A		Landing Length (in)		0.0		N/A		DWS Provided?		N/A		N/A	
						N/A		Landing Width (in)		0.0		N/A		DWS Contrast?		N/A		N/A	
		N/A		Landing Slope (%)		0.0		N/A		DWS Length (in)		N/A		N/A					
		N/A		Landing X Slope (%)		0.0		N/A		DWS Full Width?		N/A		N/A					
		N/A		Landing Curb? (Y/N)		N/A		N/A		DWS Offset LT (in)		N/A		N/A					
		N/A		Shared Landing?		N/A		N/A		DWS Offset RT (in)		N/A		N/A					
		N/A		Gutter Ponding?		0.0		N/A		Gutter Slope (%)		N/A		N/A					
		N/A		Gutter Lip Ht (in)		0.0		N/A		Gutter X Slope (%)		N/A		N/A					
		N/A		Painted X Walk1?		No				Road Slope (%)				2.2					
				X Walk 1 Direction		To W				Road X Slope (%)				1.6					
				X Walk 1 Width (in)		N/A				Clear Space?				N/A					
				X Walk 1 Slope (%)		2.2		N/A		Clear Space to XWalk (in)				N/A					
				X Walk 1 X Slope (%)		1.6		N/A		Storm Grate/Utility Hazard?				N/A

N/A		Ramp inside XWalk1?		N/A		Storm Grate/Utility Type									
				N/A		Any Obstructions?		N/A						N/A					
						Obstruction Type				Yes		Surface Condition? (G/P)		Good					
								N/A		N/A		Curb Slope (%)		7.6					
Surveyor Notes:				N/A															
PROW/ADA:				R304.5.1, R304.5.3
