Access Compliance Report

Public Rights-of-Way

(Curb Ramps)

Intersection ID: 15291	Main Street: OLD_MEADOW_RD	Cross Street: SPRINGBEAUTY_DR	Location: SE
ADA ID: E4E61F1EAE3E	Ramp Type: PerpDiag	Initial Pass/Fail: Fail	Overall Compliance: No
Severity Score: 22.5			
Codes/Mitigation Info/Possible Solution		Field Measurements/Component Compliance

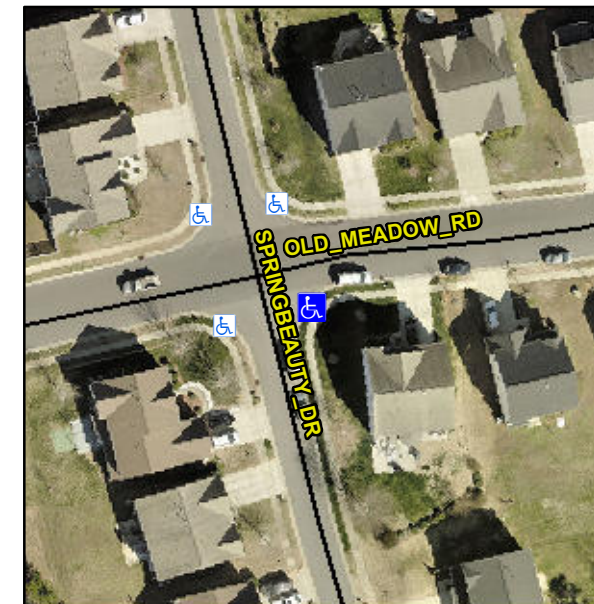
Not Found, R304.5.1, R304.2.2, R304.5.3

Compliance	Description	Data	Compliance	Description	Data
N/A	Ramp Length (in)	46.0	No	Ramp Slope (%)	9.1
No	Ramp Width (in)	44.0	No	Ramp XSlope (%)	2.7
N/A	Flare Type LT	N/A	N/A	Flare Type RT	N/A
N/A	Flare Slope LT (%)	N/A	N/A	Flare Slope RT (%)	N/A
N/A	Flare Traversable LT?	N/A	N/A	Flare Traversable RT?	N/A
N/A	Landing Length (in)	N/A	N/A	DWS Provided?	N/A
N/A	Landing Width (in)	N/A	N/A	DWS Contrast?	N/A
N/A	Landing Slope (%)	N/A	N/A	DWS Length (in)	N/A
N/A	Landing X Slope (%)	N/A	N/A	DWS Full Width?	N/A
N/A	Landing Curb? (Y/N)	N/A	N/A	DWS Offset (in)	N/A
N/A	Shared Landing?	N/A			
N/A	Gutter Ponding?	N/A	N/A	Gutter Slope (%)	N/A
N/A	Gutter Lip Ht (in)	N/A	N/A	Gutter X Slope (%)	N/A
N/A	Painted X Walk1?	No	N/A	Painted X Walk2?	No
	X Walk 1 Direction	To N		X Walk 2 Direction	To W
N/A	X Walk 1 Width (in)	N/A	N/A	X Walk 2 Width (in)	N/A
	X Walk 1 Slope (%)	3.4		X Walk 2 Slope (%)	3.9
	X Walk 1 X Slope (%)	4.0		X Walk 2 X Slope (%)	2.6

N/A	Ramp inside XWalk1?	N/A	N/A	Ramp inside XWalk2?	N/A
	Road Slope (%)	1.5	N/A	Clear Space?	N/A
	Road X Slope (%)	6.3	N/A	Clear Space to XWalk (in)	N/A
N/A	Any Obstructions?	N/A	N/A	Storm Grate/Utility Hazard?	N/A
	Obstruction Type			Storm Grate/Utility Type	
		N/A			N/A
			Yes	Surface Condition? (G/P)	Good

Remove & Replace Curb Ramp With Two New Directional Ramps or Equivalent.
