## Access Compliance Report Public Rights-of-Way (Curb Ramps)

Intersection ID: 42580 Main Street: GERALDINE\_POWE\_DR Cross Street: RISING\_OAK\_DR Location: SE

ADA ID: E4E94F6B2B91 Ramp Type: Perp Initial Pass/Fail: Pass Overall Compliance: No Severity Score: 5

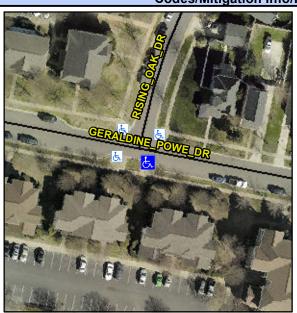
Not Found, R304.2.1, R302.7,
R304.5.4

Field Measurements/Component Compliance					
Compliance Description		Data	Compliance Description		Data
N/A	Ramp Length (in)	138.5	Yes	Ramp Slope (%)	5.2
Yes	Ramp Width (in)	55.0	Yes	Ramp XSlope (%)	0.7
N/A	Flare Type LT	Sloped	N/A	Flare Type RT	N/A
N/A	Flare Slope LT (%)	8.3	Yes	Flare Slope RT (%)	8.2
N/A	Flare Traversable LT?	Yes	N/A	Flare Traversable RT?	Yes
No	Landing Length (in)	47.0	Yes	DWS Provided?	Yes
Yes	Landing Width (in)	55.0	Yes	DWS Contrast?	Yes
Yes	Landing Slope (%)	1.4	Yes	DWS Length (in)	24.0
Yes	Landing X Slope (%)	0.9	Yes	DWS Full Width?	Yes
N/A	Landing Curb? (Y/N)	No	Yes	DWS Offset (in)	0.0
N/A	Shared Landing?	No			
No	Gutter Ponding?	Yes	No	Gutter Slope (%)	7.8
Yes	Gutter Lip Ht (in)	0.0	Yes	Gutter X Slope (%)	1.7
N/A	Painted X Walk1?	No	N/A	Painted X Walk2?	N/A
	X Walk 1 Direction	To N		X Walk 2 Direction	N/A
N/A	X Walk 1 Width (in)	N/A	N/A	X Walk 2 Width (in)	N/A
	X Walk 1 Slope (%)	3.9		X Walk 2 Slope (%)	N/A

X Walk 1 X Slope (%)	0.0		X Walk 2 X Slope (%)	N/A
N/A	Ramp inside XWalk1?	N/A	N/A	Ramp inside XWalk2?	N/A
	Road Slope (%)	N/A	N/A	Clear Space?	Yes
	Road X Slope (%)	N/A	N/A	Clear Space to XWalk (in)	N/A
Yes	Any Obstructions?	No	Yes	Storm Grate/Utility Hazard?	No
	Obstruction Type			Storm Grate/Utility Type	
		N/A			N/A
			Yes	Surface Condition? (G/P)	Good
	The state of the s

Remove & Replace Entire Ramp.
Remove & Replace Gutter.
