## Access Compliance Report Public Rights-of-Way (Curb Ramps)

Intersection ID: 3285	Main Street: MALLARD_CREEK_RD			Street:	JOHNSTON_OEHLER	Location:	W		
ADA ID: E4ECA9779425	Ramp Type: Perp			Initial Pass/Fail: Fail Overall Compliance:					
Codes/Mitigation Info/Possible Solution			minut	<u>ucon (</u>					
				Field Measurements/Component Compliance					
	1/1/3	Possible Solutions:		Compliance Description			Data Compliance Description		Data
	1111	Remove & Replace Entire Ramp	•	N/A	Ramp Length (in)	90.5		Ramp Slope (%)	12.6
1923	1 1			Yes	Ramp Width (in)	70.5		Ramp XSlope (%)	3.5
A March Last	Hide			N/A	Flare Type LT	N/A	N/A	Flare Type RT	N/A
A A A A A A A A A A A A A A A A A A A	1 1 4 18	2		N/A	Flare Slope LT (%)	N/A	N/A	Flare Slope RT (%)	N/A
	144			N/A	Flare Traversable LT?	N/A	N/A	Flare Traversable RT?	N/A

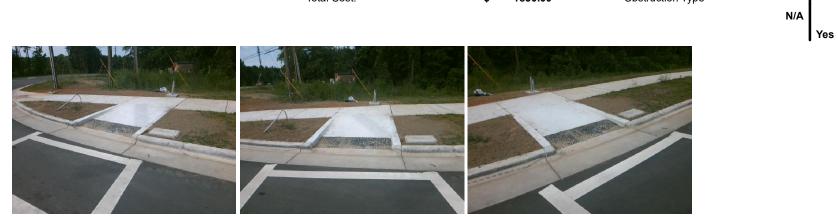
C. C.	2		N/A	Landing Length (in)	N/A	N/A	DWS Provided?	N/A
	<mark>له</mark>	Surveyor Notes:		N/A	Landing Width (in)	N/A	N/A	DWS Contrast?	N/A
		N/A		N/A	Landing Slope (%)	N/A	N/A	DWS Length (in)	N/A

B. S.	EL .	£		N/A	Landing X Slope (%)	N/A	N/A	DWS Full Width?	N/A
	the second			N/A	Landing Curb? (Y/N)	N/A	N/A	DWS Offset (in)	N/A
a	1 de la	ġ.		N/A	Shared Landing?	N/A			
A CARLER AND A CARLE	A State	PROW/ADA:		N/A	Gutter Ponding?	N/A	N/A	Gutter Slope (%)	N/A
251 251 251		R304.2.2, R304.5.3		N/A	Gutter Lip Ht (in)	N/A	N/A	Gutter X Slope (%)	N/A
	State 1			N/A	Painted X Walk1?	Yes	N/A	Painted X Walk2?	N/A
All English with the	a Maria				X Walk 1 Direction	To NE		X Walk 2 Direction	N/A

1.1.1			N/A	X Walk 1 Width (in)	104.0	N/A	X Walk 2 Width (in)	N/A
Street 1 Name JOHNSTON OEHLER RD					X Walk 1 Slope (%)	0.9		X Walk 2 Slope (%)	N/A
Stop Condition-Street 2	Signal				X Walk 1 X Slope (%)	2.7		X Walk 2 X Slope (%)	N/A
Street 2 Name	N/A			N/A	Ramp inside XWalk1?	Yes	N/A	Ramp inside XWalk2?	N/A
Stop Condition-Street 1	N/A				Road Slope (%)	N/A	N/A	Clear Space?	N/A
					Road X Slope (%)	N/A	N/A	Clear Space to XWalk (in)	N/A
				N/A	Any Obstructions?	N/A	N/A	Storm Grate/Utility Hazard?	N/A
		Total Cost: \$	1850.00		Obstruction Type			Storm Grate/Utility Type	
						N/A			N/A
