Access Compliance Report Public Rights-of-Way (Curb Ramps)

Intersection ID: 28216	Main Street: JAMES_RICHARD_DR				Street:	PEPPERWICH_PL	Location:	SE		
ADA ID: E4FA86CD4221	4221 Ramp Type: Perp				Pass/Fa	ail: Pass Overal	o Severity Score:	0		
Codes/Mitigation Info/Possible Solution					Field Measurements/Component Compliance					
		Possible Solutions:			Compliance Description			Data Compliance Description		
	1 1 13	Remove & Replace En	tire Ram	n.	N/A	Ramp Length (in)	47.0	Yes	Ramp Slope (%)	5.5
	Here and a start			P .	Yes	Ramp Width (in)	48.0	Yes	Ramp XSlope (%)	0.9
	a series the series				N/A	Flare Type LT	Sloped	N/A	Flare Type RT	N/A
	And Call				N/A	Flare Slope LT (%)	3.8		Flare Slope RT (%)	1.4
	The state				N/A	Flare Traversable LT?	No	N/A	Flare Traversable RT?	Yes
	the marked 1	R			No	Landing Length (in)	45.0	Yes	DWS Provided?	Yes
	PEPPE	Surveyor Notes:			Yes	Landing Width (in)	48.0	Yes	DWS Contrast?	Yes
	CANCE PL	N/A			No	Landing Slope (%)	3.4	Yes	DWS Length (in)	24.5

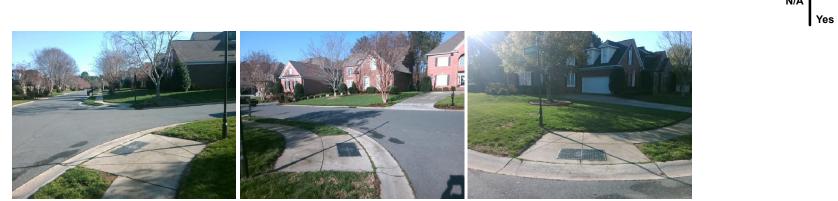
THE DOWN				Yes	Landing X Slope (%)	1.2	Yes	DWS Full Width?	Yes
	- I A LA GARD				N/A	Landing Curb? (Y/N)	No	No	DWS Offset (in)	8.0
					N/A	Shared Landing?	No			
	Mar Friday	PROW/ADA:			Yes	Gutter Ponding?	No	Yes	Gutter Slope (%)	1.4
101 1500	man har stall	Not Found, R304.2.1, F	304.2.2-	Perp.	Yes	Gutter Lip Ht (in)	0.0	Yes	Gutter X Slope (%)	0.7
	R304.3.2-Para, R305.2		· • · P,	N/A	Painted X Walk1?	No	N/A	Painted X Walk2?	N/A	
					X Walk 1 Direction	To NE		X Walk 2 Direction	N/A	
				N/A	X Walk 1 Width (in)	N/A	N/A	X Walk 2 Width (in)	N/A	
Street 1 Name	PEPPERWICH PL	-				X Walk 1 Slope (%)	2.2		X Walk 2 Slope (%)	N/A
Stop Condition-Street 2	StopSign					X Walk 1 X Slope (%)	0.0		X Walk 2 X Slope (%)	N/A
Street 2 Name	N/A				N/A	Ramp inside XWalk1?	N/A	N/A	Ramp inside XWalk2?	N/A
Stop Condition-Street 1	N/A					Road Slope (%)	N/A	N/A	Clear Space?	Yes
						Road X Slope (%)	N/A	N/A	Clear Space to XWalk (in)	N/A

Yes	Any Obstructions?	No	Yes	Storm Grate/Utility Hazard?	No
		Total Cost:	\$	1850.00		Obstruction Type			Storm Grate/Utility Type	
							N/A			N/A
