# Access Compliance Report

## Public Rights-of-Way

### (Curb Ramps)

| Intersection ID: 10038266 | Main Street: SMITHFIELD_CHURCH_RD | Cross Street: N/A | Location: W |

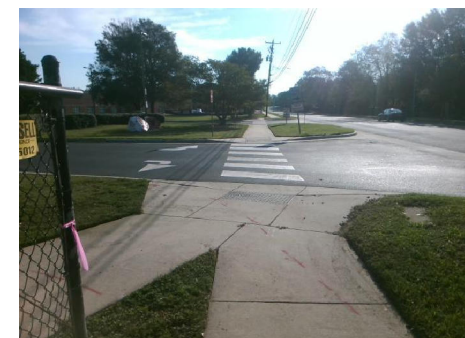
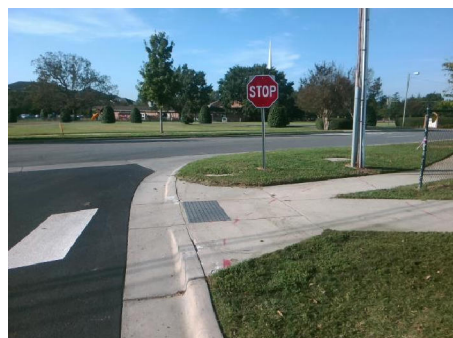
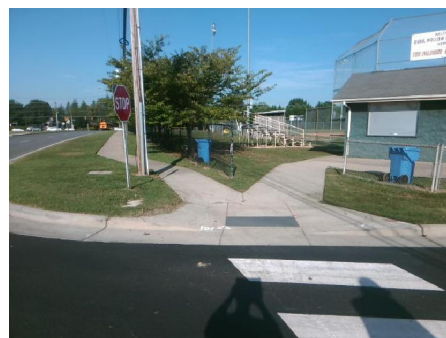
| ADA ID: E514D8361B76 | Ramp Type: BlendTrans1 | Initial Pass/Fail: Fail | Overall Compliance: No |
| Severity Score: 8.75 | | | |

**Not Found, R304.5.1**

| Compliance | Description | Data | Compliance | Description | Data |
|---|---|---|---|---|---|
| No | Ramp Width (in) | 47.0 | Yes | BlendTrans XSlope (%) | 0.5 |
| | | | No | Curb Slope (%) | 5.5 |

**Remove & Replace Curb Ramp With Two New Directional Ramps or Equivalent.**

Total Cost: \$ 3200.00
