# Access Compliance Report

## Public Rights-of-Way

| Intersection ID: 22027 | Main Street: CAMBRIDGE CRESCENT DR | Cross Street: CARMEL CRESCENT DR | Location: W |
| ADA ID: E5182445BC26 | Ramp Type: PerpDiag | Initial Pass/Fail: Pass | Overall Compliance: No |

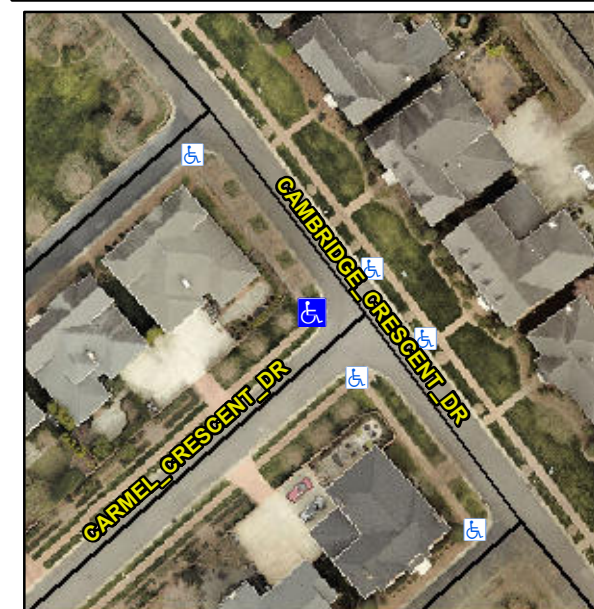
**Not Found, R304.5.3, R304.2.2-Perp, R304.3.2-Para, R305, R302.7.2, R304.5.4**

| Compliance | Description | Data | Compliance | Description | Data |
|---|---|---|---|---|---|
| N/A | Ramp Length (in) | 71.0 | Yes | Ramp Slope (%) | 7.3 |
| Yes | Ramp Width (in) | 48.0 | No | Ramp XSlope (%) | 4.6 |
| Yes | Landing Length (in) | 49.0 | No | DWS Provided? | No |
| No | Landing Slope (%) | 3.3 | N/A | DWS Length (in) | N/A |
| No | Landing X Slope (%) | 2.8 | N/A | DWS Full Width? | No |
| Yes | Gutter Ponding? | No | No | Gutter Slope (%) | 5.8 |
| No | Gutter Lip Ht (in) | 0.5 | Yes | Gutter X Slope (%) | 1.1 |

**Remove & Replace Curb Ramp With Two New Directional Ramps or Equivalent. Remove & Replace Gutter.**

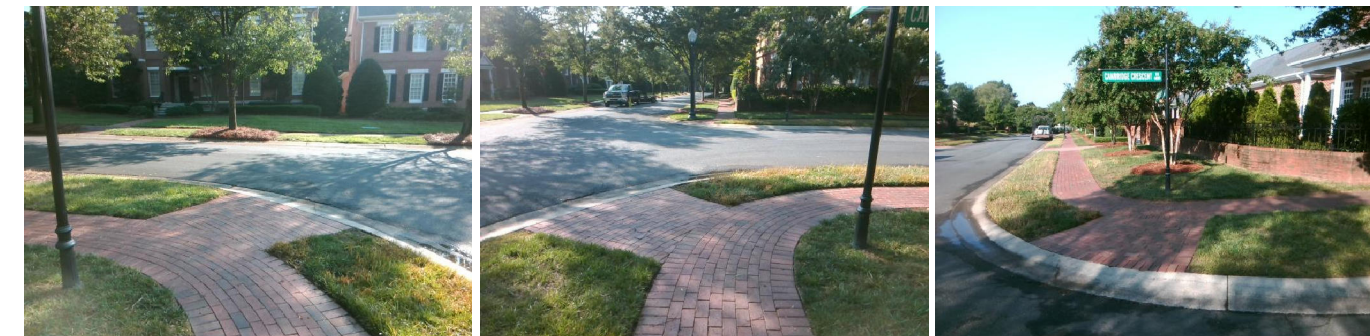
Street 1 Name CARMEL CRESCENT DR  
 Stop Condition-Street 2 StopSign  
 Street 2 Name CAMBRIDGE CRESCENT DR  
 Stop Condition-Street 1 None
