Access Compliance Report

Public Rights-of-Way

(Curb Ramps)

Intersection ID: 16920	Main Street: IDLEWILD_RD	Cross Street: CEDARWILD_RD	Location:	N
ADA ID: E5265AC6B9D6	Ramp Type: PerpDiag	Initial Pass/Fail: Fail	Overall Compliance: No	Severity Score: 12.5

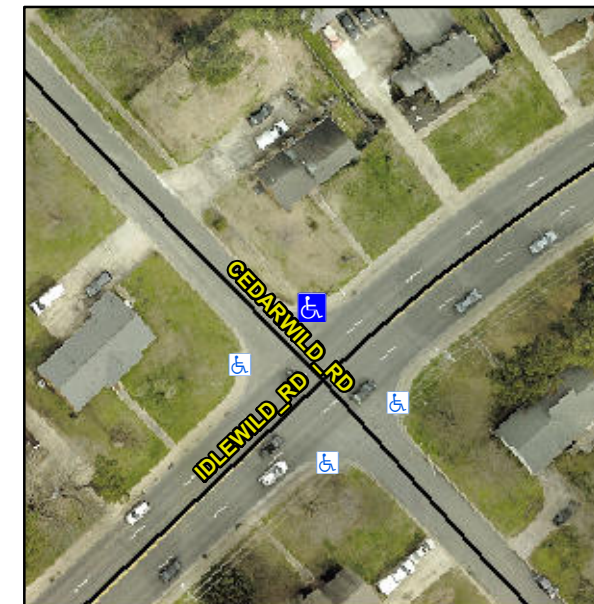
Not Found, R304.2.2

Compliance	Description	Data	Compliance	Description	Data
N/A	Ramp Length (in)	64.0	No	Ramp Slope (%)	8.5
Yes	Ramp Width (in)	48.0	Yes	Ramp XSlope (%)	0.1
N/A	Flare Type LT	N/A	N/A	Flare Type RT	N/A
N/A	Flare Slope LT (%)	N/A	N/A	Flare Slope RT (%)	N/A
N/A	Flare Traversable LT?	N/A	N/A	Flare Traversable RT?	N/A
N/A	Landing Length (in)	N/A	N/A	DWS Provided?	N/A
N/A	Landing Width (in)	N/A	N/A	DWS Contrast?	N/A
N/A	Landing Slope (%)	N/A	N/A	DWS Length (in)	N/A
N/A	Landing X Slope (%)	N/A	N/A	DWS Full Width?	N/A
N/A	Landing Curb? (Y/N)	N/A	N/A	DWS Offset (in)	N/A
N/A	Shared Landing?	N/A			
N/A	Gutter Ponding?	N/A	N/A	Gutter Slope (%)	N/A
N/A	Gutter Lip Ht (in)	N/A	N/A	Gutter X Slope (%)	N/A
N/A	Painted X Walk1?	No	N/A	Painted X Walk2?	No
	X Walk 1 Direction	To SW		X Walk 2 Direction	To SE
N/A	X Walk 1 Width (in)	N/A	N/A	X Walk 2 Width (in)	N/A
	X Walk 1 Slope (%)	0.3		X Walk 2 Slope (%)	3.3
	X Walk 1 X Slope (%)	1.7		X Walk 2 X Slope (%)	1.3

N/A	Ramp inside XWalk1?	N/A	N/A	Ramp inside XWalk2?	N/A
	Road Slope (%)	1.7	N/A	Clear Space?	N/A
	Road X Slope (%)	0.3	N/A	Clear Space to XWalk (in)	N/A
N/A	Any Obstructions?	N/A	N/A	Storm Grate/Utility Hazard?	N/A
	Obstruction Type			Storm Grate/Utility Type	
		N/A			N/A
			Yes	Surface Condition? (G/P)	Good

Remove & Replace Curb Ramp With Two New Directional Ramps or Equivalent.
