# Access Compliance Report

## Public Rights-of-Way

### (Curb Ramps)

Intersection ID: 13575	Main Street: KENHILL_DR	Cross Street: MARKLAND_DR	Location: SE
ADA ID: E532EE06D9EB	Ramp Type: PerpDiag	Initial Pass/Fail: Fail	Overall Compliance: No
		Severity Score: 8.75

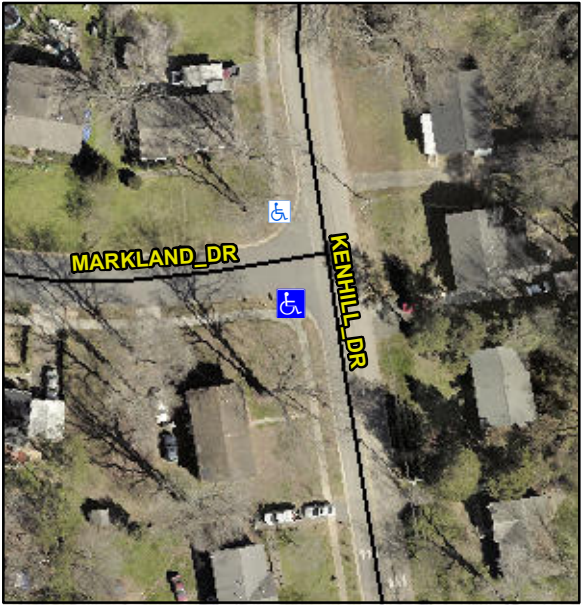
Possible Solutions:		<b>Compliance</b>	<b>Description</b>	<b>Data</b>
	<b>Remove &amp; Replace Curb Ramp With Two New Directional Ramps or Equivalent.</b>		<b>Yes</b>	Ramp Length (in)	7.5
			<b>No</b>	Ramp Width (in)	0.8
			<b>N/A</b>	Flare Type LT	N/A
			<b>N/A</b>	Flare Slope LT (%)	N/A
			<b>N/A</b>	Flare Traversable LT?	N/A
			<b>N/A</b>	Landing Length (in)	N/A
			<b>N/A</b>	Landing Width (in)	N/A
			<b>N/A</b>	Landing Slope (%)	N/A
			<b>N/A</b>	Landing X Slope (%)	N/A
<p>Surveyor Notes:</p> <p><b>N/A</b></p> <p>PROW/ADA:</p> <p><b>R304.5.1</b></p>			<b>Yes</b>	Ramp Slope (%)	7.5
			<b>Yes</b>	Ramp XSlope (%)	0.8
			<b>N/A</b>	Flare Type RT	N/A
			<b>N/A</b>	Flare Slope RT (%)	N/A
			<b>N/A</b>	Flare Traversable RT?	N/A
			<b>N/A</b>	DWS Provided?	N/A
			<b>N/A</b>	DWS Contrast?	N/A
			<b>N/A</b>	DWS Length (in)	N/A

<b>N/A</b>	DWS Full Width?	N/A
			<b>N/A</b>	DWS Offset (in)	N/A
			<b>N/A</b>	Shared Landing?	N/A
			<b>N/A</b>	Gutter Ponding?	N/A
			<b>N/A</b>	Gutter Lip Ht (in)	N/A
			<b>No</b>	Painted X Walk1?	No
				X Walk 1 Direction	To E
			<b>N/A</b>	X Walk 1 Width (in)	N/A
				X Walk 1 Slope (%)	8.4
				X Walk 1 X Slope (%)	5.7
			<b>N/A</b>	Ramp inside XWalk1?	N/A
			<b>N/A</b>	Road Slope (%)	4.5
			<b>N/A</b>	Road X Slope (%)	9.5
			<b>N/A</b>	Any Obstructions?	N/A
				Obstruction Type	
			<b>N/A</b>		N/A
			<b>Yes</b>	Surface Condition? (G/P)	Good
