Access Compliance Report Public Rights-of-Way (Curb Ramps)

| Intersection ID: 7635 | Main Street: PHEASANT_GLEN_RD | | | street: | QUAIL_ST | Location: | SW | | |
| ADA ID: E534142DFDF4 | Ramp Type: PerpDiag | | | itial Pass/Fail: Fail Overall Compliance: No | | | | o Severity Score: | 46.25 |

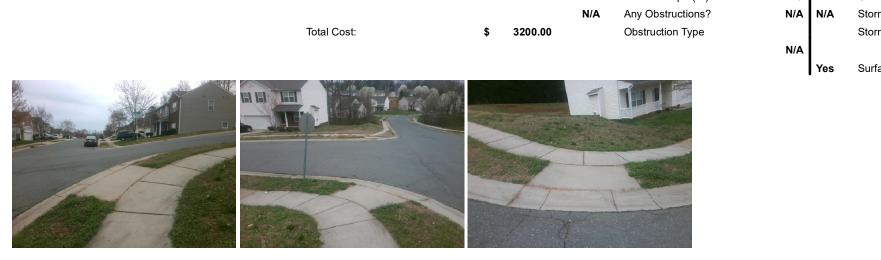
| Intersection ID: 7635 | Main Street: PHEASANT_GLEN_RD | | | street: | QUAIL_ST | Location: | SW | | |
|---|---|--|---|--|---|---|---|---|---|
| FILEASANT_ eLEN_R | | Remove & Replace Curb Ramp W | Vith | N/A | Ramp Length (in) | 93.0 | No | Ramp Slope (%) | 9.5 |
| | | Two New Directional Ramps or | | No | Ramp Width (in) | 46.0 | No | Ramp XSlope (%) | 24.4 |
| | | Not Found, R304.5.1, R304.2.2, R304.5.3 | | N/A | Painted X Walk1? | N/A No | N/A | Painted X Walk2? | N/A No |
| all with the preserve and a | Section of a stability | 1004.5.5 | | 11/1 | X Walk 1 Direction | To E | | X Walk 2 Direction | To N |

| Intersection ID: 7635 | Main Street: PHEASANT_GLEN_RD | | | street: | QUAIL_ST | Location: | SW | | |
|---|---|--|---|--|---|---|---|---|---|
| | | Equivalent. | | N/A | Flare Type LT | N/A | N/A | Flare Type RT | N/A |
| | | Total Cost: \$ 3 | 200.00 | | Obstruction Type | | | Storm Grate/Utility Type | |
