Access Compliance Report

Public Rights-of-Way

(Curb Ramps)

Intersection ID: 44072	Main Street: SEDGEMOOR_LN	Cross Street: OVERSTONE_CT	Location: NW
ADA ID: E53D98C0CF81	Ramp Type: PerpDiag	Initial Pass/Fail: Fail	Overall Compliance: No
		Severity Score: 35

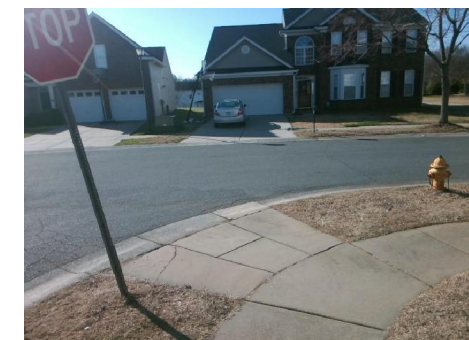
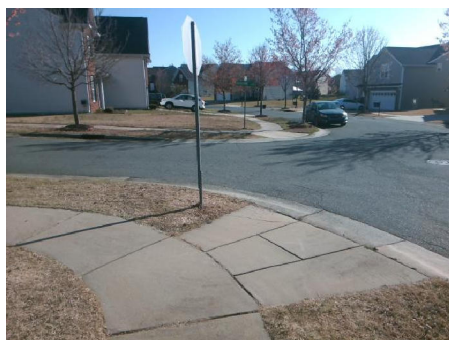
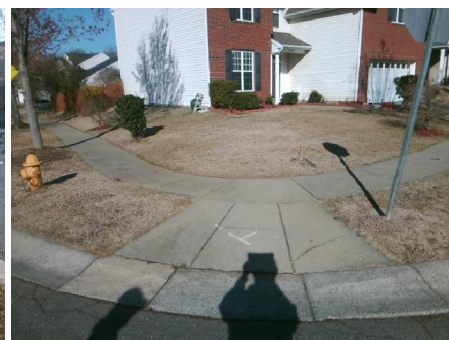
Compliance	Description	Data	Compliance	Description	Data
N/A	Ramp Length (in)	70.0	Yes	Ramp Slope (%)	5.6
No	Ramp Width (in)	25.0	Yes	Ramp XSlope (%)	0.5
N/A	Flare Type LT	N/A	N/A	Flare Type RT	N/A
N/A	Flare Slope LT (%)	N/A	N/A	Flare Slope RT (%)	N/A
N/A	Flare Traversable LT?	N/A	N/A	Flare Traversable RT?	N/A
N/A	Landing Length (in)	N/A	N/A	DWS Provided?	N/A
N/A	Landing Width (in)	N/A	N/A	DWS Contrast?	N/A
N/A	Landing Slope (%)	N/A	N/A	DWS Length (in)	N/A
N/A	Landing X Slope (%)	N/A	N/A	DWS Full Width?	N/A
N/A	Landing Curb? (Y/N)	N/A	N/A	DWS Offset (in)	N/A
N/A	Shared Landing?	N/A			
N/A	Gutter Ponding?	N/A	N/A	Gutter Slope (%)	N/A
N/A	Gutter Lip Ht (in)	N/A	N/A	Gutter X Slope (%)	N/A
N/A	Painted X Walk1?	No	N/A	Painted X Walk2?	No
	X Walk 1 Direction	To SE		X Walk 2 Direction	To NE
N/A	X Walk 1 Width (in)	N/A	N/A	X Walk 2 Width (in)	N/A
	X Walk 1 Slope (%)	0.7		X Walk 2 Slope (%)	0.6
	X Walk 1 X Slope (%)	0.0		X Walk 2 X Slope (%)	3.0

N/A	Ramp inside XWalk1?	N/A	N/A	Ramp inside XWalk2?	N/A
	Road Slope (%)	2.4	N/A	Clear Space?	N/A
	Road X Slope (%)	1.3	N/A	Clear Space to XWalk (in)	N/A
N/A	Any Obstructions?	N/A	N/A	Storm Grate/Utility Hazard?	N/A
	Obstruction Type			Storm Grate/Utility Type	
		N/A			N/A
			Yes	Surface Condition? (G/P)	Good

Remove & Replace Curb Ramp With Two New Directional Ramps or Equivalent.

Total Cost: \$ 3200.00
