## Access Compliance Report Public Rights-of-Way (Curb Ramps)

Intersection ID: 30459	459 Main Street: STEELE_MEADOW_RD C				CADES_COVE_DR	Location:	NW			
ADA ID: E55DC0B2008C	2008C Ramp Type: PerpDiag Ir			itial Pass/Fail: Fail Overall Compliance: No				o Severity Score:	12.5	
Codes/Mitigation Info/Possible Solution					Field Measurements/Component Compliance					
Possible Solutions:				Compliance Description Data Compliance					Data	
		Remove & Replace Curb Ramp		N/A	Ramp Length (in)	45.0	No	Ramp Slope (%)	9.8	
		Two New Directional Ramps o Equivalent.		Yes	Ramp Width (in)	48.0	Yes	Ramp XSlope (%)	2.0	
		Equivalent.		N/A	Flare Type LT	N/A	N/A	Flare Type RT	N/A	
				N/A	Flare Slope LT (%)		N/A	Flare Slope RT (%)	N/A	
		74		N/A	Flare Traversable LT?	N/A	N/A	Flare Traversable RT?	N/A	
				N/A	Landing Length (in)	N/A	N/A	DWS Provided?	N/A	
The second second		Surveyor Notes:		N/A	Landing Width (in)	N/A	N/A	DWS Contrast?	N/A	
<mark></mark>		N/A		N/A	Landing Slope (%)	N/A	N/A	DWS Length (in)	N/A

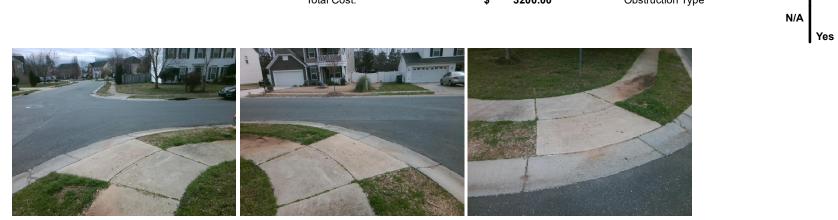
CADES_COVE_DR		5		N/A	Landing X Slope (%)	N/A	N/A	DWS Full Width?	N/A	
t.				N/A	Landing Curb? (Y/N)	N/A	N/A	DWS Offset (in)	N/A	
A B B B B B B B B B B B B B B B B B B B		6		N/A	Shared Landing?	N/A				
the state		PROW/ADA:		N/A	Gutter Ponding?	N/A	N/A	Gutter Slope (%)	N/A	
10		Not Found, R304.2.2		N/A	Gutter Lip Ht (in)	N/A	N/A	Gutter X Slope (%)	N/A	
		· · · · · , · · ·		N/A	Painted X Walk1?	No	N/A	Painted X Walk2?	No	
	A IS ADO				X Walk 1 Direction	To S		X Walk 2 Direction	To E	
		×		N/A	X Walk 1 Width (in)	N/A	N/A	X Walk 2 Width (in)	N/A	
Street 1 Name	CADES COVE DR				X Walk 1 Slope (%)	1.0		X Walk 2 Slope (%)	3.0	
Stop Condition-Street 2	StopSign				X Walk 1 X Slope (%)	2.5		X Walk 2 X Slope (%)	0.4	
Street 2 Name	STEELE MEADOW RD			N/A	Ramp inside XWalk1?	N/A	N/A	Ramp inside XWalk2?	N/A	
Stop Condition-Street 1	None				Road Slope (%)	0.8	N/A	Clear Space?	N/A	
					Road X Slope (%)	4.8	N/A	Clear Space to XWalk (in)	N/A

N/A	Any Obstructions?	N/A	N/A	Storm Grate/Utility Hazard?	N/A	
		Total Cost: \$	3200.00		Obstruction Type			Storm Grate/Utility Type		
						N/A			N/A
