# Access Compliance Report

## Public Rights-of-Way

### (Curb Ramps)

Intersection ID: 27404	Main Street: BALLANTYNE_COMMONS_PY	Cross Street: MEADOW_RUN_LN	Location: NE
ADA ID: E57D5469C51A	Ramp Type: Perp	Initial Pass/Fail: Fail	Overall Compliance: No
Severity Score: 22.5			
Codes/Mitigation Info/Possible Solution		Field Measurements/Component Compliance

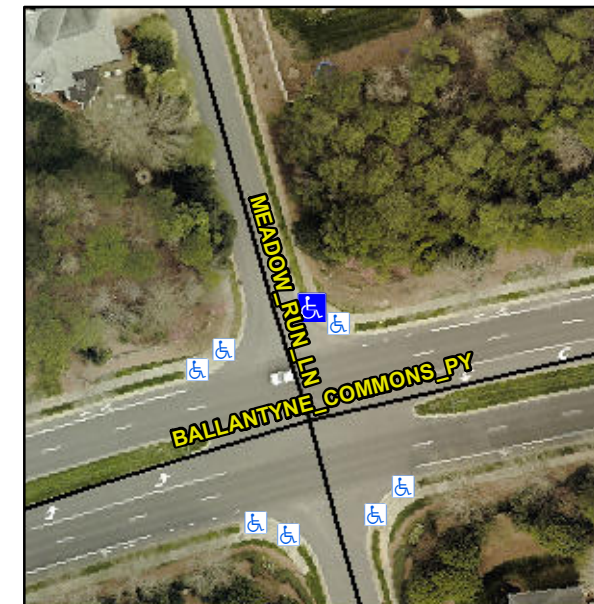
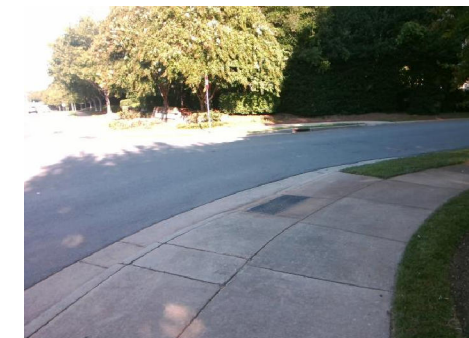
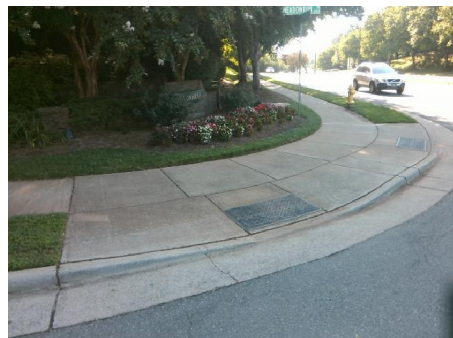
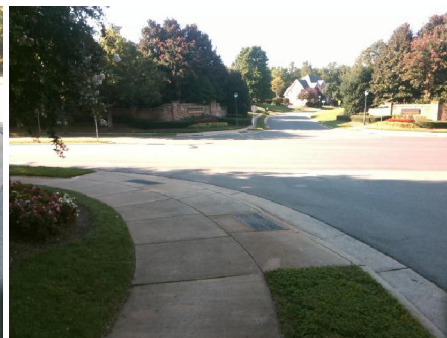
**Not Found, R304.5.1, R304.2.2, R304.5.3**

Compliance	Description	Data	Compliance	Description	Data
N/A	Ramp Length (in)	47.0	No	Ramp Slope (%)	10.4
No	Ramp Width (in)	44.5	No	Ramp XSlope (%)	4.5
N/A	Flare Type LT	N/A	N/A	Flare Type RT	N/A
N/A	Flare Slope LT (%)	N/A	N/A	Flare Slope RT (%)	N/A
N/A	Flare Traversable LT?	N/A	N/A	Flare Traversable RT?	N/A
N/A	Landing Length (in)	N/A	N/A	DWS Provided?	N/A
N/A	Landing Width (in)	N/A	N/A	DWS Contrast?	N/A
N/A	Landing Slope (%)	N/A	N/A	DWS Length (in)	N/A
N/A	Landing X Slope (%)	N/A	N/A	DWS Full Width?	N/A
N/A	Landing Curb? (Y/N)	N/A	N/A	DWS Offset (in)	N/A
N/A	Shared Landing?	N/A			
N/A	Gutter Ponding?	N/A	N/A	Gutter Slope (%)	N/A
N/A	Gutter Lip Ht (in)	N/A	N/A	Gutter X Slope (%)	N/A
N/A	Painted X Walk1?	No	N/A	Painted X Walk2?	N/A
	X Walk 1 Direction	To SW		X Walk 2 Direction	N/A
N/A	X Walk 1 Width (in)	N/A	N/A	X Walk 2 Width (in)	N/A
	X Walk 1 Slope (%)	2.3		X Walk 2 Slope (%)	N/A
	X Walk 1 X Slope (%)	3.2		X Walk 2 X Slope (%)	N/A

N/A	Ramp inside XWalk1?	N/A	N/A	Ramp inside XWalk2?	N/A
	Road Slope (%)	N/A	N/A	Clear Space?	N/A
	Road X Slope (%)	N/A	N/A	Clear Space to XWalk (in)	N/A
N/A	Any Obstructions?	N/A	N/A	Storm Grate/Utility Hazard?	N/A
	Obstruction Type			Storm Grate/Utility Type	
		N/A			N/A
			Yes	Surface Condition? (G/P)	Good

**Remove & Replace Entire Ramp.**

Total Cost: \$ 1850.00
