Access Compliance Report

Public Rights-of-Way

(Curb Ramps)

Intersection ID: 42363	Main Street: CONDOR_CR	Cross Street: KESTRAL_RIDGE_DR	Location: NW
ADA ID: E58D459F2379	Ramp Type: BlendTrans1	Initial Pass/Fail: Pass	Overall Compliance: No
			Severity Score: 10.25

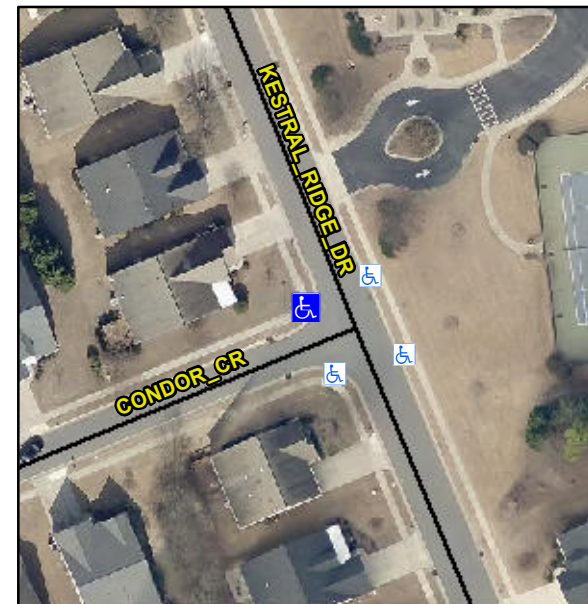
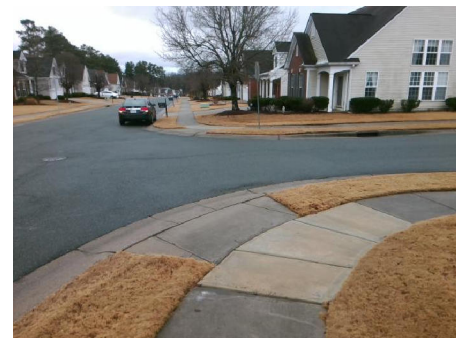
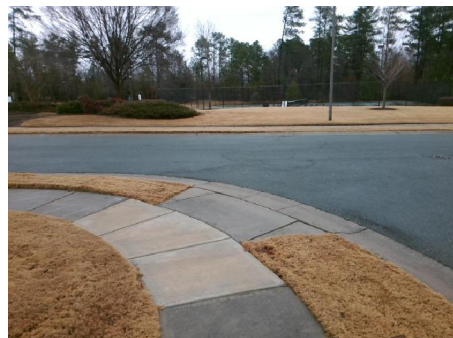
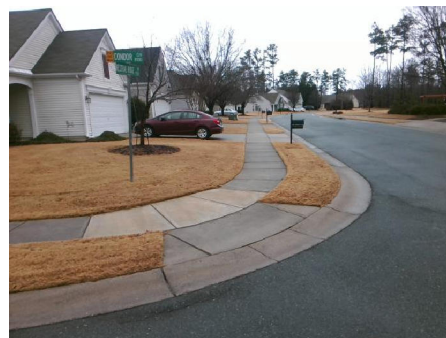
Not Found, R304.5.3, R304.2.2-Perp, R304.3.2-Para, R305

Compliance	Description	Data	Compliance	Description	Data
N/A	Ramp Length (in)	46.0	Yes	BlendTrans Slope (%)	1.3
Yes	Ramp Width (in)	73.0	No	BlendTrans XSlope (%)	2.6
N/A	Flare Type LT	Sloped	N/A	Flare Type RT	Sloped
N/A	Flare Slope LT (%)	2.0	N/A	Flare Slope RT (%)	5.1
N/A	Flare Traversable LT?	No	N/A	Flare Traversable RT?	No
Yes	Landing Length (in)	55.0	No	DWS Provided?	No
Yes	Landing Width (in)	68.0	N/A	DWS Contrast?	No
No	Landing Slope (%)	7.7	N/A	DWS Length (in)	N/A
No	Landing X Slope (%)	2.6	N/A	DWS Full Width?	No
N/A	Landing Curb? (Y/N)	No	N/A	DWS Offset (in)	N/A
N/A	Shared Landing?	No			
Yes	Gutter Ponding?	No	Yes	Gutter Slope (%)	4.0
Yes	Gutter Lip Ht (in)	0.0	No	Gutter X Slope (%)	3.0
N/A	Painted X Walk1?	No	N/A	Painted X Walk2?	No
	X Walk 1 Direction	To S		X Walk 2 Direction	To E
	X Walk 1 Width (in)	N/A		X Walk 2 Width (in)	N/A
	X Walk 1 Slope (%)	1.4		X Walk 2 Slope (%)	2.6
	X Walk 1 X Slope (%)	1.8		X Walk 2 X Slope (%)	2.3

N/A	Ramp inside XWalk1?	N/A	N/A	Ramp inside XWalk2?	N/A
	Road Slope (%)	3.0		Clear Space?	Yes
	Road X Slope (%)	1.0	N/A	Clear Space to XWalk (in)	N/A
Yes	Any Obstructions?	No	Yes	Storm Grate/Utility Hazard?	No
	Obstruction Type			Storm Grate/Utility Type	
		N/A			N/A
			Yes	Surface Condition? (G/P)	Good
			No	Curb Slope (%)	5.4

Possible Solutions:

Remove & Replace Curb Ramp With Two New Directional Ramps or Equivalent. Remove & Replace Gutter.
