# Access Compliance Report

## Public Rights-of-Way

### (Curb Ramps)

Intersection ID: 27884	Main Street: PARADISE RIDGE RD	Cross Street: RIESLING CT	Location: NW
ADA ID: E5A7498EFB6C	Ramp Type: Perp	Initial Pass/Fail: Fail	Overall Compliance: No
			Severity Score: 13.75

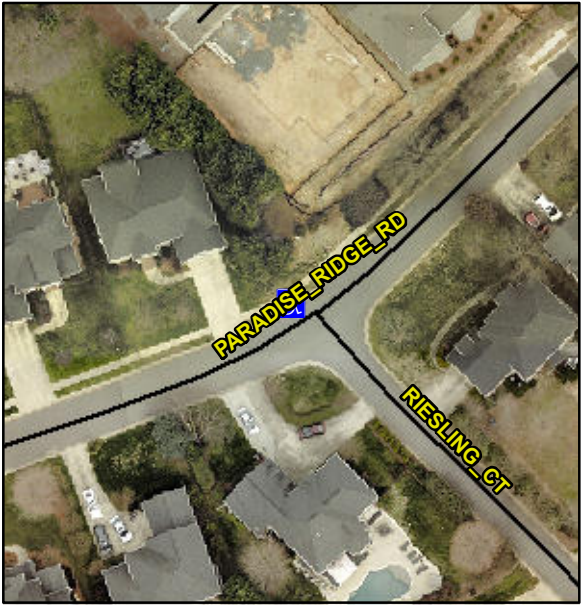
Possible Solutions:		<b>Compliance</b>	<b>Description</b>	<b>Data</b>
	Remove & Replace Entire Ramp.		N/A	Ramp Length (in)	40.0
			Yes	Ramp Width (in)	64.0
			N/A	Flare Type LT	N/A
			N/A	Flare Slope LT (%)	N/A
			N/A	Flare Traversable LT?	N/A
			N/A	Landing Length (in)	N/A
			N/A	Landing Width (in)	N/A
			N/A	Landing Slope (%)	N/A
			N/A	Landing X Slope (%)	N/A
<p>Surveyor Notes:</p> <p>N/A</p> <p>PROW/ADA:</p> <p>R304.2.2, R304.5.3</p>			N/A	Flare Type RT	N/A
			N/A	Flare Slope RT (%)	N/A
			N/A	Flare Traversable RT?	N/A
			N/A	DWS Provided?	N/A
			N/A	DWS Contrast?	N/A
			N/A	DWS Length (in)	N/A
			N/A	DWS Full Width?	N/A
			N/A	DWS Offset (in)	N/A
			N/A	Gutter Ponding?	N/A
			N/A	Gutter Lip Ht (in)	N/A
			N/A	Painted X Walk1?	No
				X Walk 1 Direction	To S
			N/A	X Walk 1 Width (in)	N/A
				X Walk 1 Slope (%)	4.3
				X Walk 1 X Slope (%)	3.4
