Intersection ID: 51046	Main Street: LONGNOR_ST	Cross Street: PALATINE_LN	Location:	W
ADA ID: E5BADDF99D62	Ramp Type: Perp	Initial Pass/Fail: Pass	Overall Compliance: No	Severity Score: 7.5

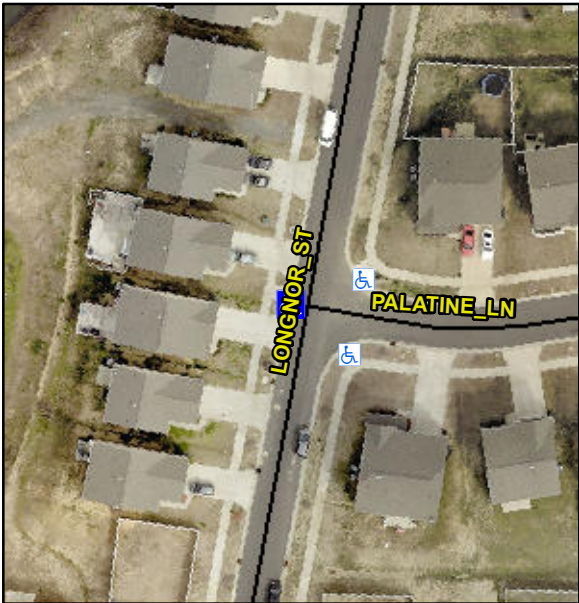
Possible Solutions:		Compliance	Description	Data	Compliance	Description	Data
	Remove & Replace Entire Ramp.		N/A	Ramp Length (in)	95.0	Yes	Ramp Slope (%)	6.2
	Remove & Replace Gutter.		Yes	Ramp Width (in)	60.0	Yes	Ramp XSlope (%)	1.1
			N/A	Flare Type LT	Sloped	N/A	Flare Type RT	N/A
			N/A	Flare Slope LT (%)	4.8	No	Flare Slope RT (%)	11.6
			N/A	Flare Traversable LT?	Yes	N/A	Flare Traversable RT?	Yes
			Yes	Landing Length (in)	60.0	Yes	DWS Provided?	Yes
			Yes	Landing Width (in)	60.0	Yes	DWS Contrast?	Yes
			Yes	Landing Slope (%)	0.9	Yes	DWS Length (in)	24.0
			Yes	Landing X Slope (%)	0.1	Yes	DWS Full Width?	Yes
Surveyor Notes: N/A			N/A	Landing Curb? (Y/N)	No	No	DWS Offset (in)	3.0
			N/A	Shared Landing?	No			
			Yes	Gutter Ponding?	No	No	Gutter Slope (%)	7.1
			Yes	Gutter Lip Ht (in)	0.0	Yes	Gutter X Slope (%)	2.3

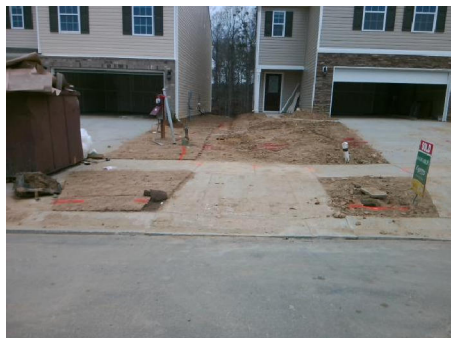
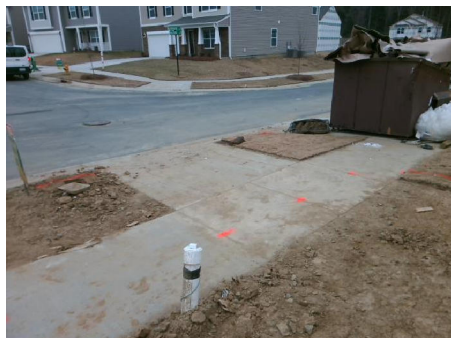
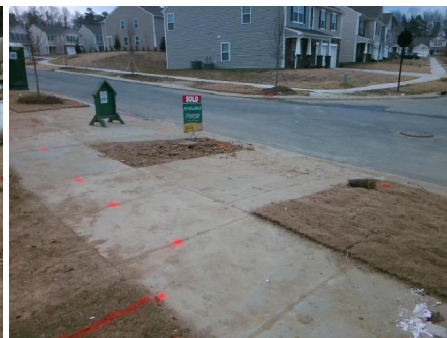
N/A	Painted X Walk1?	No	N/A	Painted X Walk2?	N/A
				X Walk 1 Direction	To E		X Walk 2 Direction	N/A
			N/A	X Walk 1 Width (in)	N/A	N/A	X Walk 2 Width (in)	N/A
				X Walk 1 Slope (%)	4.5		X Walk 2 Slope (%)	N/A
				X Walk 1 X Slope (%)	3.0		X Walk 2 X Slope (%)	N/A
			N/A	Ramp inside XWalk1?	N/A	N/A	Ramp inside XWalk2?	N/A
PROW/ADA: Not Found, R304.2.3, R305.2, R304.5.4				Road Slope (%)	N/A	N/A	Clear Space?	Yes
				Road X Slope (%)	N/A	N/A	Clear Space to XWalk (in)	N/A
			Yes	Any Obstructions?	No	Yes	Storm Grate/Utility Hazard?	No
				Obstruction Type			Storm Grate/Utility Type	
						N/A		N/A
						Yes	Surface Condition? (G/P)	Good
	Total Cost:	\$ 2600.00						
Street 1 Name		LONGNOR ST						
Stop Condition-Street 2		None						
Street 2 Name		N/A						
Stop Condition-Street 1		N/A
