Access Compliance Report Public Rights-of-Way (Curb Ramps)

Intersection ID: 8126 Main Street: IRMA_ST Cross Street: NEWLAND_RD Location: SW

ADA ID: E5D1221730B6 Ramp Type: Combination1 Initial Pass/Fail: Fail Overall Compliance: No Severity Score: 46.25

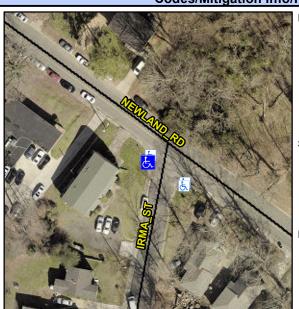
RT RP < 5%

Not Found, R304.5.1, R304.2.2, R304.5.3, R304.3.2

Compliance Description Data Compliance Description Ramp Length LT (in) N/A N/A 66.0 Ramp Length RT (in) 48.0 Yes Ramp Width LT (in) Yes Ramp Width RT (in) No Ramp Slope LT (%) 10.5 Yes Ramp Slope RT (%) Ramp XSlope LT (%) No Ramp XSlope RT (%) No 6.3 N/A Ramp Length (in) 48.0 Nο Ramp Slope (%) 41.0 No Ramp XSlope (%) No Ramp Width (in) N/A Flare Type LT N/A N/A Flare Type RT N/A N/A Flare Slope LT (%) N/A Flare Slope RT (%) N/A Flare Traversable LT? N/A N/A Flare Traversable RT? N/A Landing Length (in) N/A N/A DWS Provided? N/A N/A N/A Landing Width (in) **DWS Contrast?** N/A Landing Slope (%) N/A N/A DWS Length (in) N/A Landing X Slope (%) N/A N/A DWS Full Width? N/A Landing Curb? (Y/N) N/A N/A DWS Offset (in) N/A Shared Landing? N/A N/A **Gutter Ponding?** N/A N/A Gutter Slope (%) N/A N/A Gutter Lip Ht (in) N/A Gutter X Slope (%) N/A Painted X Walk2? N/A Painted X Walk1? No To W X Walk 1 Direction X Walk 2 Direction X Walk 1 Width (in) N/A X Walk 2 Width (in) 4.2 X Walk 1 Slope (%) X Walk 2 Slope (%) X Walk 1 X Slope (%) 4.0 X Walk 2 X Slope (%)

Remove & Replace Entire Ramp.
