Intersection ID: N/A	Main Street: I-485_RA	Cross Street: W_W_T_HARRIS_BV	Location:	E
ADA ID: E5D8B195DAA4	Ramp Type: Perp	Initial Pass/Fail: Pass	Overall Compliance: No	Severity Score: 15.25

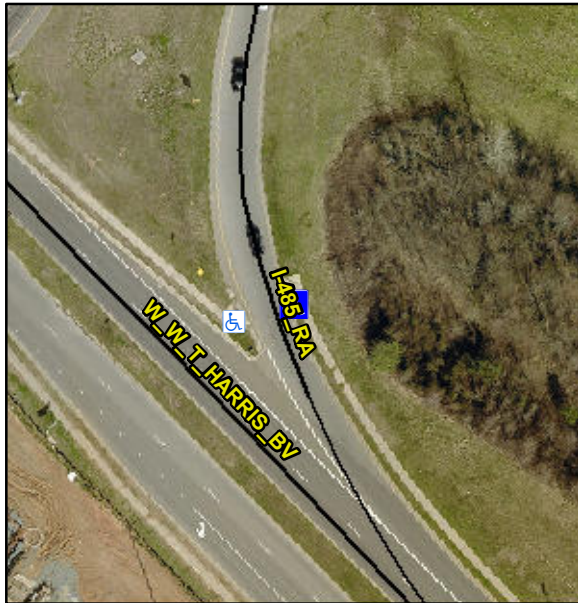
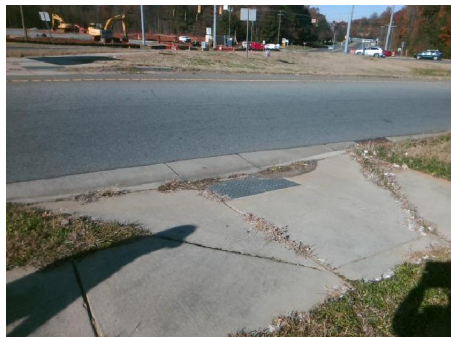
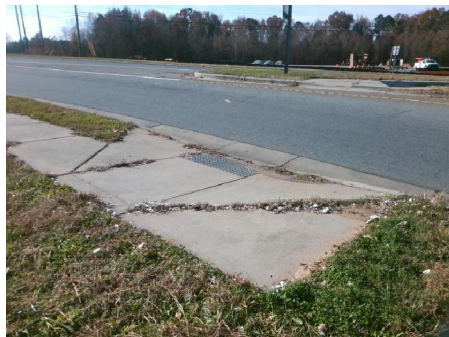
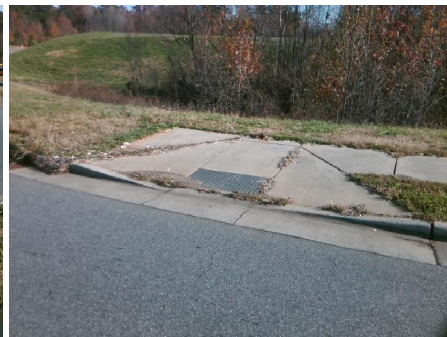
**Not Found, R304.5.3, R304.2.1,
R304.2.2-Perp, R304.3.2-Para,
R305.2, R304.5.4**

Compliance	Description	Data	Compliance	Description	Data
N/A	Ramp Length (in)	101.0	Yes	Ramp Slope (%)	6.6
Yes	Ramp Width (in)	48.0	No	Ramp XSlope (%)	4.8
N/A	Flare Type LT	Sloped	N/A	Flare Type RT	N/A
N/A	Flare Slope LT (%)	2.3	N/A	Flare Slope RT (%)	10.9
N/A	Flare Traversable LT?	No	N/A	Flare Traversable RT?	No
No	Landing Length (in)	N/A	Yes	DWS Provided?	Yes
No	Landing Width (in)	N/A	Yes	DWS Contrast?	Yes
No	Landing Slope (%)	N/A	Yes	DWS Length (in)	24.0
No	Landing X Slope (%)	N/A	Yes	DWS Full Width?	Yes
N/A	Landing Curb? (Y/N)	No	No	DWS Offset (in)	3.5
N/A	Shared Landing?	No			
Yes	Gutter Ponding?	No	No	Gutter Slope (%)	10.5
Yes	Gutter Lip Ht (in)	0.0	No	Gutter X Slope (%)	5.9
N/A	Painted X Walk1?	No	N/A	Painted X Walk2?	N/A
	X Walk 1 Direction	To W		X Walk 2 Direction	N/A
N/A	X Walk 1 Width (in)	N/A	N/A	X Walk 2 Width (in)	N/A
	X Walk 1 Slope (%)	6.8		X Walk 2 Slope (%)	N/A
	X Walk 1 X Slope (%)	3.7		X Walk 2 X Slope (%)	N/A

N/A	Ramp inside XWalk1?	N/A	N/A	Ramp inside XWalk2?	N/A
	Road Slope (%)	N/A	N/A	Clear Space?	Yes
	Road X Slope (%)	N/A	N/A	Clear Space to XWalk (in)	N/A
Yes	Any Obstructions?	No	Yes	Storm Grate/Utility Hazard?	No
	Obstruction Type			Storm Grate/Utility Type	
		N/A			N/A
			Yes	Surface Condition? (G/P)	Good

**Remove & Replace Entire Ramp.
Remove & Replace Gutter.**
