Access Compliance Report Public Rights-of-Way (Curb Ramps)

Intersection ID: 10034403 Main Street: PIEDMONT_ROW_DR_SOUTH Cross Street: N/A Location: NE

ADA ID: E5F95DED6BBC Ramp Type: PerpDiag Initial Pass/Fail: Fail Overall Compliance: No Severity Score: 8.75

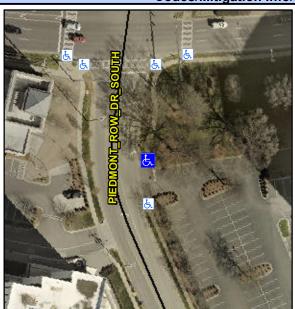
Not Found, R304.5.1	
Total Cost:	\$ 3200.

Comp	liance Description	Data	Comp	liance	Description	Data
N/A	Ramp Length (in)	53.0	Yes	Ram	Slope (%)	6.9
No	Ramp Width (in)	46.0	Yes	Ram	XSlope (%)	1.9
N/A	Flare Type LT	N/A	N/A	Flare	Type RT	N/A
N/A	Flare Slope LT (%)	N/A	N/A	Flare	Slope RT (%)	N/A
N/A	Flare Traversable LT?	N/A	N/A	Flare	Traversable RT?	N/A
N/A	Landing Length (in)	N/A	N/A	DWS	Provided?	N/A
N/A	Landing Width (in)	N/A	N/A	DWS	Contrast?	N/A
N/A	Landing Slope (%)	N/A	N/A	DWS	Length (in)	N/A
N/A	Landing X Slope (%)	N/A	N/A	DWS	Full Width?	N/A
N/A	Landing Curb? (Y/N)	N/A	N/A	DWS	Offset (in)	N/A
N/A	Shared Landing?	N/A				
N/A	Gutter Ponding?	N/A	N/A	Gutte	er Slope (%)	N/A
N/A	Gutter Lip Ht (in)	N/A	N/A	Gutte	er X Slope (%)	N/A
N/A	Painted X Walk1?	No	N/A	Paint	ed X Walk2?	No
	X Walk 1 Direction	To W		X Wa	lk 2 Direction	To SW
N/A	X Walk 1 Width (in)	N/A	N/A	X Wa	lk 2 Width (in)	N/A
	X Walk 1 Slope (%)	0.7		X Wa	lk 2 Slope (%)	2.3
	X Walk 1 X Slope (%)	2.5		X Wa	lk 2 X Slope (%)	0.1

N/A	Ramp inside XWalk1?	N/A	N/A	Ram	o inside XWalk2?	N/A
	Road Slope (%)	1.7	N/A	Clear	Space?	N/A
	Road X Slope (%)	2.1	N/A	Clear	Space to XWalk (in)	N/A
N/A	Any Obstructions?	N/A	N/A	Storn	n Grate/Utility Hazard?	N/A
	Obstruction Type		l	Storn	n Grate/Utility Type	
		N/A				N/A

Remove & Replace Curb Ramp With
Two New Directional Ramps or
Equivalent.
