# Access Compliance Report

## Public Rights-of-Way

### (Curb Ramps)

| Intersection ID: 47708 | Main Street: ERWIN_RD | Cross Street: ROCKCASTLE_DR | Location: SE |

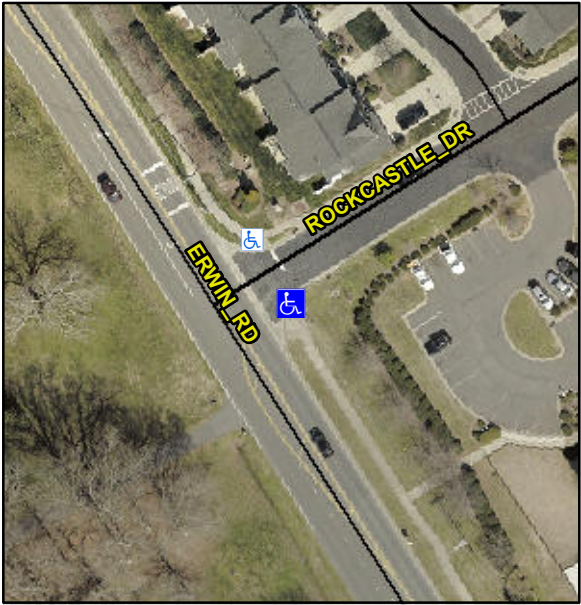
| ADA ID: E60348F3264D | Ramp Type: PerpDiag | Initial Pass/Fail: Fail | Overall Compliance: No |

| Codes/Mitigation Info/Possible Solution | | Field Measurements/Component Compliance | | | |
|---|---|---|---|---|---|
| | PROW/ADA: | <b>Not Found, R304.5.1, R304.5.3</b> | | | |
| | | | <b>No</b> | <b>Ramp XSlope (%)</b> | <b>5.2</b> |

| Codes/Mitigation Info/Possible Solution | | Field Measurements/Component Compliance | | | |
|---|---|---|---|---|---|
| <p>Street 1 Name <b>ROCKCASTLE DR</b></p> <p>Stop Condition-Street 2 <b>StopSign</b></p> <p>Street 2 Name <b>ERWIN RD</b></p> <p>Stop Condition-Street 1 <b>None</b></p> | Possible Solutions: | <b>Remove &amp; Replace Curb Ramp With Two New Directional Ramps or Equivalent.</b> | | | |

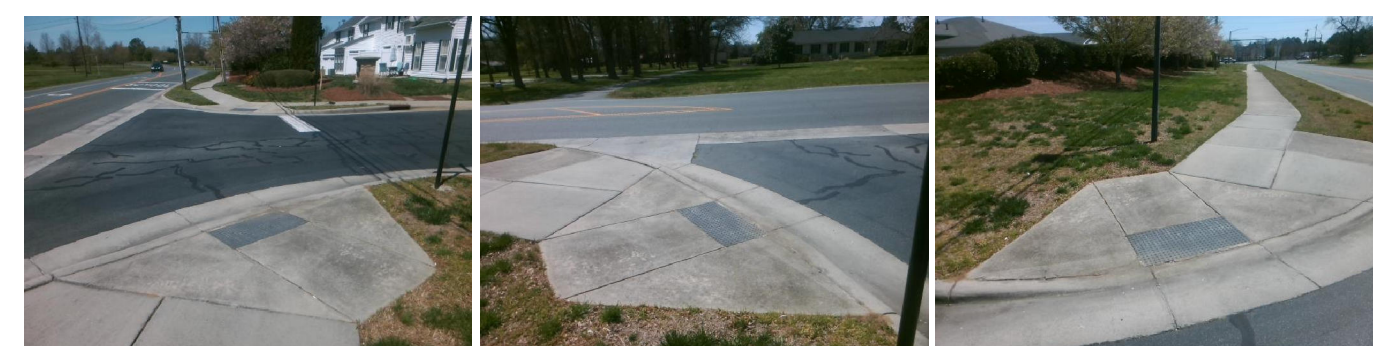
| | | Severity Score: 21.25 | |

| Codes/Mitigation Info/Possible Solution | | Field Measurements/Component Compliance | | | |
|---|---|---|---|---|---|
| | | | <b>Yes</b> | <b>Ramp Slope (%)</b> | <b>5.7</b> |

| Codes/Mitigation Info/Possible Solution | | Field Measurements/Component Compliance | | | |
|---|---|---|---|---|---|
| | Total Cost: | <b>\$ 3200.00</b> | | | |
