# Access Compliance Report

## Public Rights-of-Way

### (Curb Ramps)

| Intersection ID: 10036931 | Main Street: S_SHARON_AMITY_RD | Cross Street: N/A | Location: NW |

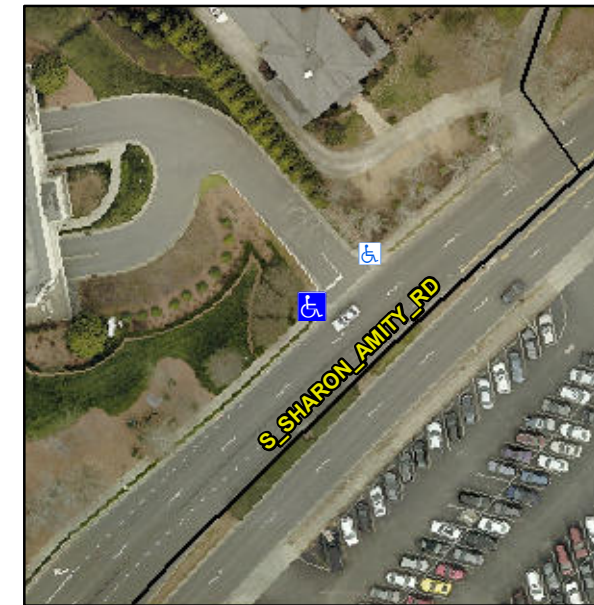
| ADA ID: E6166467747B | Ramp Type: PerpDiag | Initial Pass/Fail: Fail | Overall Compliance: No |

**N/A**

**Not Found, R304.5.3**

| Compliance | Description | Data | Compliance | Description | Data |
|---|---|---|---|---|---|
| Yes | Ramp Width (in) | 48.0 | No | Ramp XSlope (%) | 5.3 |

**Remove & Replace Curb Ramp With Two New Directional Ramps or Equivalent.**

Total Cost: \$ 3200.00
