# Access Compliance Report

## Public Rights-of-Way

### (Curb Ramps)

Intersection ID: N/A	Main Street: NEAL_RD	Cross Street: SPRINGMIST_DR	Location: NW
ADA ID: E61C485CFB6B	Ramp Type: Combination2Diag	Initial Pass/Fail: Fail	Overall Compliance: No
		Severity Score: 0

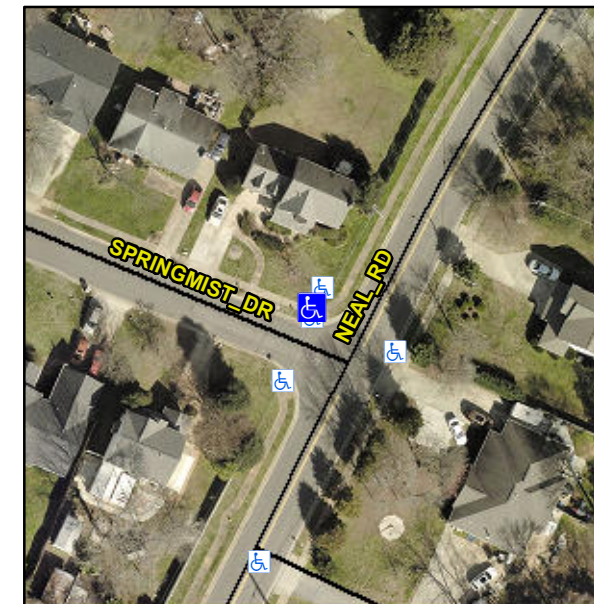
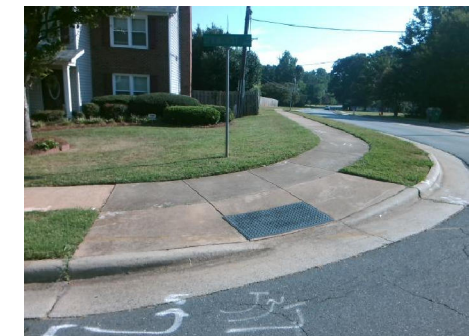
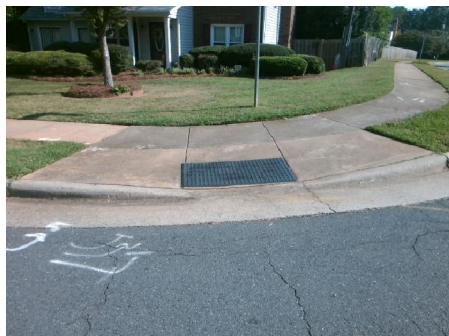
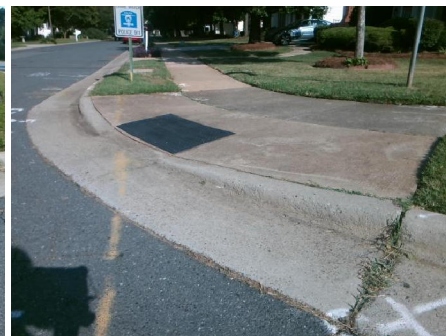
**Not Found, R304.5.1, R304.5.1, R304.2.2, R304.5.3, R304.3.2**

Compliance	Description	Data	Compliance	Description	Data
N/A	Ramp Length LT (in)	39.0	N/A	Ramp Length RT (in)	40.0
Yes	Ramp Width LT (in)	48.5	No	Ramp Width RT (in)	47.5
Yes	Ramp Slope LT (%)	4.7	No	Ramp Slope RT (%)	8.9
No	Ramp XSlope LT (%)	3.8	Yes	Ramp XSlope RT (%)	1.5
N/A	Ramp Length (in)	48.0	No	Ramp Slope (%)	8.9
No	Ramp Width (in)	47.0	No	Ramp XSlope (%)	5.7
N/A	Flare Type LT	N/A	N/A	Flare Type RT	N/A
N/A	Flare Slope LT (%)	N/A	N/A	Flare Slope RT (%)	N/A
N/A	Flare Traversable LT?	N/A	N/A	Flare Traversable RT?	N/A
N/A	Landing Length (in)	N/A	N/A	DWS Provided?	N/A
N/A	Landing Width (in)	N/A	N/A	DWS Contrast?	N/A
N/A	Landing Slope (%)	N/A	N/A	DWS Length (in)	N/A
N/A	Landing X Slope (%)	N/A	N/A	DWS Full Width?	N/A
N/A	Landing Curb? (Y/N)	N/A	N/A	DWS Offset (in)	N/A
N/A	Shared Landing?	N/A			
N/A	Gutter Ponding?	N/A	N/A	Gutter Slope (%)	N/A
N/A	Gutter Lip Ht (in)	N/A	N/A	Gutter X Slope (%)	N/A
N/A	Painted X Walk1?	No	N/A	Painted X Walk2?	No

X Walk 1 Direction	To S		X Walk 2 Direction	To E
	X Walk 1 Width (in)	N/A		X Walk 2 Width (in)	N/A
	X Walk 1 Slope (%)	1.4		X Walk 2 Slope (%)	4.6
	X Walk 1 X Slope (%)	3.7		X Walk 2 X Slope (%)	0.5
N/A	Ramp inside XWalk1?	N/A	N/A	Ramp inside XWalk2?	N/A
	Road Slope (%)	2.8		Clear Space?	N/A
	Road X Slope (%)	1.9	N/A	Clear Space to XWalk (in)	N/A
			N/A	Any Obstruction?	N/A
				Obstruction Type	N/A
			N/A	Storm Grate/Utility Hazard?	N/A
				Storm Grate/Utility Type	N/A
Yes	Surface Condition? (G/P)	Good			
	Curb Slope (%)	7.9

**Remove & Replace Curb Ramp With Two New Directional Ramps or Equivalent.**

**\$ 3200.00**
