Access Compliance Report

Public Rights-of-Way

(Curb Ramps)

Intersection ID: 50768	Main Street: TOWERING_PINE_DR	Cross Street: SUTTONVIEW_DR	Location: SW
ADA ID: E6206E555826	Ramp Type: PerpDiag	Initial Pass/Fail: Fail	Overall Compliance: No
		Severity Score: 8.75

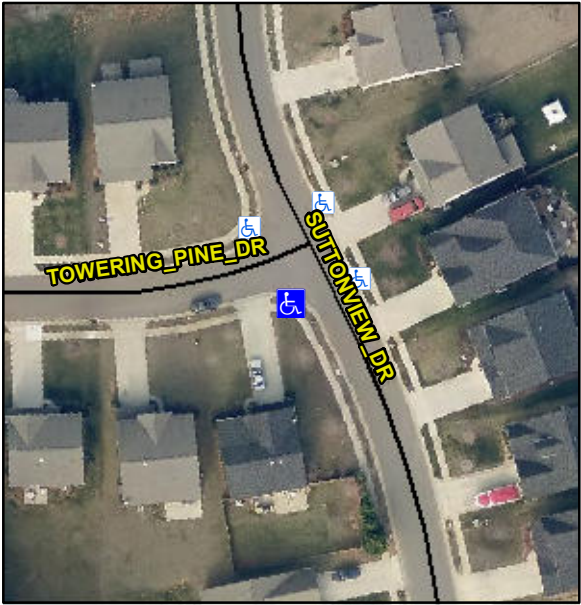
Possible Solutions:		Compliance	Description	Data
	Remove & Replace Curb Ramp With Two New Directional Ramps or Equivalent.		Yes	Ramp Length (in)	48.0
			No	Ramp Width (in)	46.5
			N/A	Flare Type LT	N/A
			N/A	Flare Slope LT (%)	N/A
			N/A	Flare Traversable LT?	N/A
			N/A	Landing Length (in)	N/A
			N/A	Landing Width (in)	N/A
			N/A	Landing Slope (%)	N/A
			N/A	Landing X Slope (%)	N/A
<p>Surveyor Notes:</p> <p>N/A</p> <p>PROW/ADA:</p> <p>Not Found, R304.5.1</p>			N/A	Flare Type RT	N/A
			N/A	Flare Slope RT (%)	N/A
			N/A	Flare Traversable RT?	N/A
			N/A	DWS Provided?	N/A
			N/A	DWS Contrast?	N/A
			N/A	DWS Length (in)	N/A
			N/A	DWS Full Width?	N/A
			N/A	DWS Offset (in)	N/A
			N/A	Gutter Ponding?	N/A
			N/A	Gutter Lip Ht (in)	N/A
			No	Painted X Walk1?	No
				X Walk 1 Direction	To E
			N/A	X Walk 1 Width (in)	N/A

3.6	X Walk 1 Slope (%)	3.6
			2.6	X Walk 1 X Slope (%)	2.6
			N/A	Ramp inside XWalk1?	N/A
			1.0	Road Slope (%)	1.0
			5.0	Road X Slope (%)	5.0
			N/A	Any Obstructions?	N/A
				Obstruction Type	
Total Cost:		\$ 3200.00	N/A	Clear Space?	N/A
			N/A	Clear Space to XWalk (in)	N/A
			N/A	Storm Grate/Utility Hazard?	N/A
				Storm Grate/Utility Type	
			N/A		N/A
			Yes	Surface Condition? (G/P)	Good
