# Access Compliance Report

## Public Rights-of-Way

### (Curb Ramps)

Intersection ID: 48457	Main Street: FOX_POINT_DR	Cross Street: PANGLEMONT_DR	Location:	E
ADA ID: E62F9D689240	Ramp Type: PerpDiag	Initial Pass/Fail: Fail	Overall Compliance: No	Severity Score: 10
Codes/Mitigation Info/Possible Solution		Field Measurements/Component Compliance

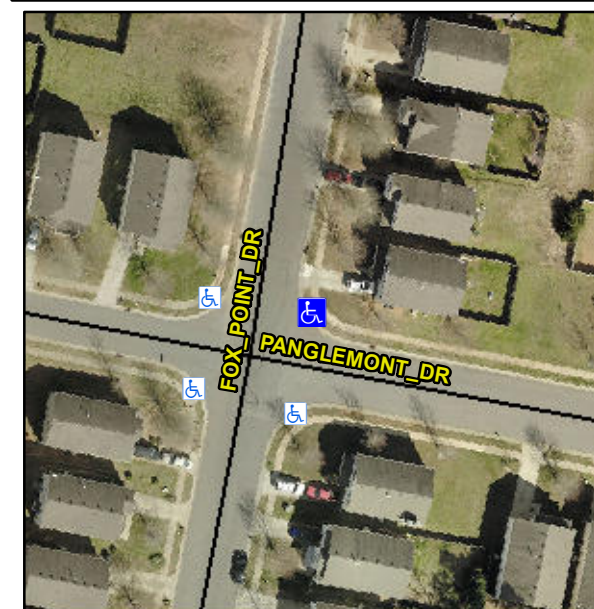
**Not Found, R304.5.1, R304.5.3**

Compliance	Description	Data	Compliance	Description	Data
N/A	Ramp Length (in)	46.0	Yes	Ramp Slope (%)	7.3
No	Ramp Width (in)	43.5	No	Ramp XSlope (%)	4.9
N/A	Flare Type LT	N/A	N/A	Flare Type RT	N/A
N/A	Flare Slope LT (%)	N/A	N/A	Flare Slope RT (%)	N/A
N/A	Flare Traversable LT?	N/A	N/A	Flare Traversable RT?	N/A
N/A	Landing Length (in)	N/A	N/A	DWS Provided?	N/A
N/A	Landing Width (in)	N/A	N/A	DWS Contrast?	N/A
N/A	Landing Slope (%)	N/A	N/A	DWS Length (in)	N/A
N/A	Landing X Slope (%)	N/A	N/A	DWS Full Width?	N/A
N/A	Landing Curb? (Y/N)	N/A	N/A	DWS Offset (in)	N/A
N/A	Shared Landing?	N/A			
N/A	Gutter Ponding?	N/A	N/A	Gutter Slope (%)	N/A
N/A	Gutter Lip Ht (in)	N/A	N/A	Gutter X Slope (%)	N/A
N/A	Painted X Walk1?	No	N/A	Painted X Walk2?	No
	X Walk 1 Direction	To NW		X Walk 2 Direction	To SW
N/A	X Walk 1 Width (in)	N/A	N/A	X Walk 2 Width (in)	N/A
	X Walk 1 Slope (%)	3.2		X Walk 2 Slope (%)	3.2
	X Walk 1 X Slope (%)	5.1		X Walk 2 X Slope (%)	2.6

N/A	Ramp inside XWalk1?	N/A	N/A	Ramp inside XWalk2?	N/A
	Road Slope (%)	4.3	N/A	Clear Space?	N/A
	Road X Slope (%)	1.1	N/A	Clear Space to XWalk (in)	N/A
N/A	Any Obstructions?	N/A	N/A	Storm Grate/Utility Hazard?	N/A
	Obstruction Type			Storm Grate/Utility Type	
		N/A			N/A
			Yes	Surface Condition? (G/P)	Good

**Remove & Replace Curb Ramp With Two New Directional Ramps or Equivalent.**
