Access Compliance Report

Public Rights-of-Way (Curb Ramps)

Intersection ID: 10040473	Main Street: VULCAN_MATERIALS_DR	Cross Street: N/A	Location: SW
ADA ID: E64399425192	Ramp Type: Perp	Initial Pass/Fail: Fail	Overall Compliance: No
		Severity Score: 22.5

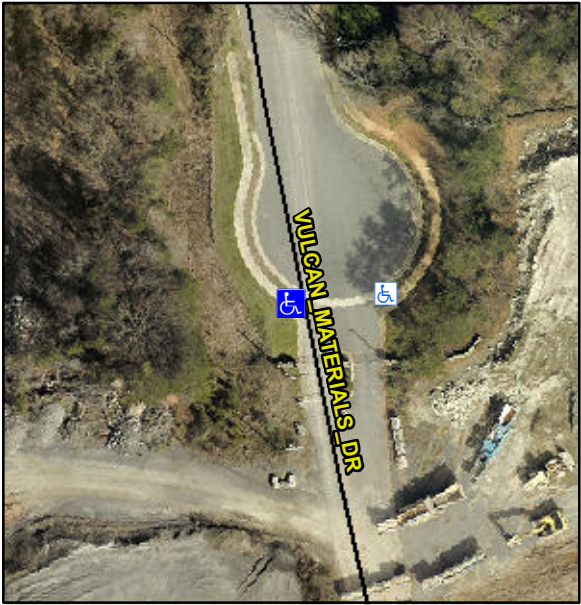
Possible Solutions:		Compliance	Description	Data
	Remove & Replace Entire Ramp.		No	Ramp Length (in)	60.0
			No	Ramp Width (in)	47.5
			N/A	Flare Type LT	N/A
			N/A	Flare Slope LT (%)	N/A
			N/A	Flare Traversable LT?	N/A
			N/A	Landing Length (in)	N/A
			N/A	Landing Width (in)	N/A
			N/A	Landing Slope (%)	N/A
			N/A	Landing X Slope (%)	N/A
<p>Surveyor Notes:</p> <p>N/A</p> <p>PROW/ADA:</p> <p>Not Found, R304.5.1, R304.2.2, R304.5.3</p>			N/A	Flare Type RT	N/A
			N/A	Flare Slope RT (%)	N/A
			N/A	Flare Traversable RT?	N/A
			N/A	DWS Provided?	N/A
			N/A	DWS Contrast?	N/A
			N/A	DWS Length (in)	N/A
			N/A	DWS Full Width?	N/A
			N/A	DWS Offset (in)	N/A
			N/A	Gutter Ponding?	N/A
			N/A	Gutter Lip Ht (in)	N/A
<p>Total Cost:</p> <p>\$ 1850.00</p>			No	Painted X Walk1?	N/A
				X Walk 1 Direction	To E
			N/A	X Walk 1 Width (in)	N/A

X Walk 1 Slope (%)	1.7
				X Walk 1 X Slope (%)	1.0
			N/A	Ramp inside XWalk1?	N/A
			N/A	Road Slope (%)	N/A
			N/A	Road X Slope (%)	N/A
			N/A	Any Obstructions?	N/A
				Obstruction Type	
			N/A	Clear Space?	N/A
			N/A	Clear Space to XWalk (in)	N/A
			N/A	Storm Grate/Utility Hazard?	N/A
				Storm Grate/Utility Type	
			N/A		N/A
			Yes	Surface Condition? (G/P)	Good
