Access Compliance Report

Public Rights-of-Way

(Curb Ramps)

Intersection ID: 9779	Main Street: CAMPUS_ST	Cross Street: CEMETERY_ST	Location: NE
ADA ID: E650A2307DA2	Ramp Type: PerpDiag	Initial Pass/Fail: Fail	Overall Compliance: No
		Severity Score: 22.5

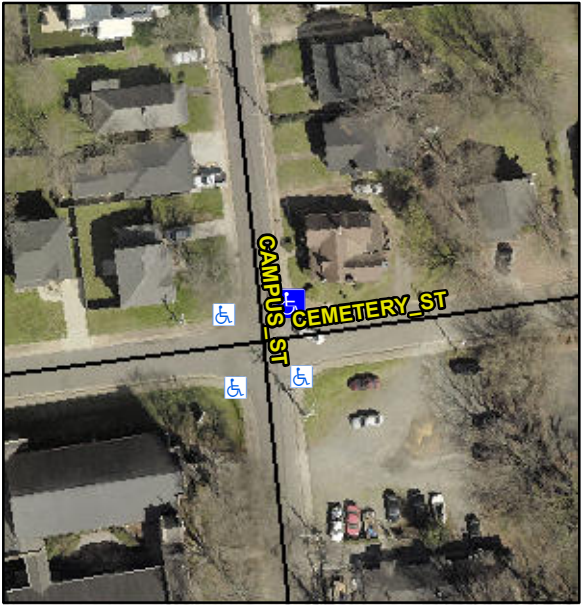
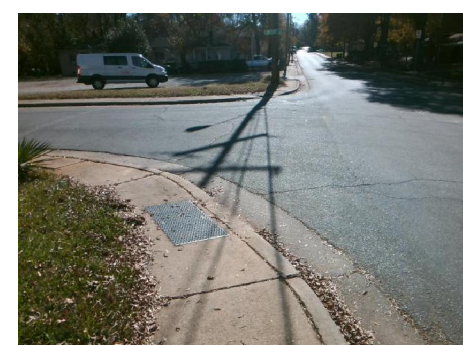
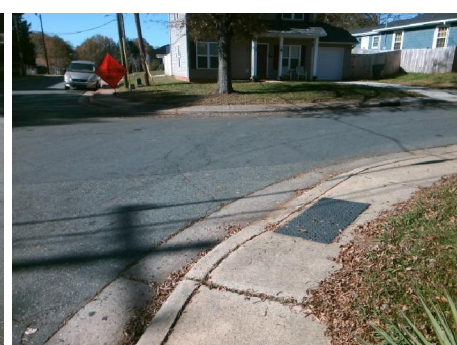
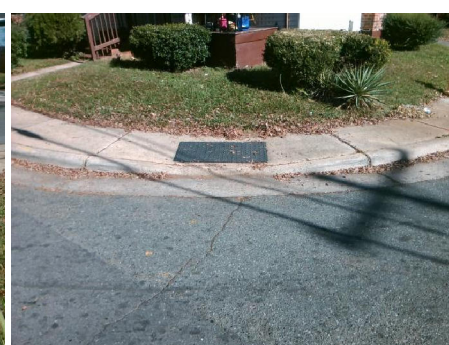
Possible Solutions:		Compliance	Description	Data
	Remove & Replace Curb Ramp With Two New Directional Ramps or Equivalent.		No	Ramp Length (in)	46.0
			No	Ramp Width (in)	44.0
			N/A	Flare Type LT	N/A
			N/A	Flare Slope LT (%)	N/A
			N/A	Flare Traversable LT?	N/A
			N/A	Landing Length (in)	N/A
			N/A	Landing Width (in)	N/A
			N/A	Landing Slope (%)	N/A
			N/A	Landing X Slope (%)	N/A
<p>Surveyor Notes:</p> <p>N/A</p> <p>PROW/ADA:</p> <p>Not Found, R304.5.1, R304.2.2, R304.5.3</p>			N/A	Flare Type RT	N/A
			N/A	Flare Slope RT (%)	N/A
			N/A	Flare Traversable RT?	N/A
			N/A	DWS Provided?	N/A
			N/A	DWS Contrast?	N/A
			N/A	DWS Length (in)	N/A
			N/A	DWS Full Width?	N/A
			N/A	DWS Offset (in)	N/A
			N/A	Shared Landing?	N/A
			N/A	Gutter Ponding?	N/A
<p>Total Cost:</p> <p>\$ 3200.00</p>			N/A	Gutter Lip Ht (in)	N/A
			N/A	Painted X Walk1?	No

X Walk 1 Direction	To W
			N/A	X Walk 1 Width (in)	N/A
				X Walk 1 Slope (%)	1.6
				X Walk 1 X Slope (%)	0.9
			N/A	Ramp inside XWalk1?	N/A
				Road Slope (%)	2.2
				Road X Slope (%)	2.7
			N/A	Any Obstructions?	N/A
				Obstruction Type	
			N/A		N/A
				Storm Grate/Utility Hazard?	N/A
				Storm Grate/Utility Type	
			N/A		N/A
			Yes	Surface Condition? (G/P)	Good
