Access Compliance Report

Public Rights-of-Way

(Curb Ramps)

Intersection ID: 10027594	Main Street: GREEN_RIDGE_DR	Cross Street: N/A	Location:	N
ADA ID: E660A623CEDF	Ramp Type: PerpDiag	Initial Pass/Fail: Fail	Overall Compliance: No	Severity Score: 12.5
Codes/Mitigation Info/Possible Solution		Field Measurements/Component Compliance

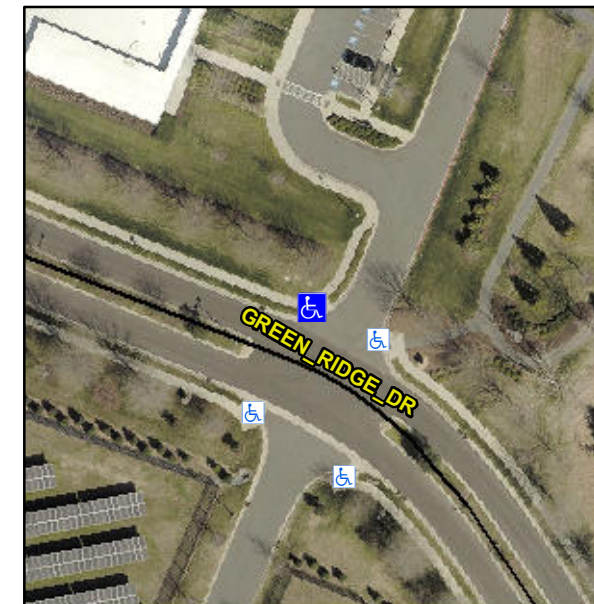
Not Found, R304.2.2

Compliance	Description	Data	Compliance	Description	Data
N/A	Ramp Length (in)	48.0	No	Ramp Slope (%)	10.0
Yes	Ramp Width (in)	48.0	Yes	Ramp XSlope (%)	0.6
N/A	Flare Type LT	N/A	N/A	Flare Type RT	N/A
N/A	Flare Slope LT (%)	N/A	N/A	Flare Slope RT (%)	N/A
N/A	Flare Traversable LT?	N/A	N/A	Flare Traversable RT?	N/A
N/A	Landing Length (in)	N/A	N/A	DWS Provided?	N/A
N/A	Landing Width (in)	N/A	N/A	DWS Contrast?	N/A
N/A	Landing Slope (%)	N/A	N/A	DWS Length (in)	N/A
N/A	Landing X Slope (%)	N/A	N/A	DWS Full Width?	N/A
N/A	Landing Curb? (Y/N)	N/A	N/A	DWS Offset (in)	N/A
N/A	Shared Landing?	N/A			
N/A	Gutter Ponding?	N/A	N/A	Gutter Slope (%)	N/A
N/A	Gutter Lip Ht (in)	N/A	N/A	Gutter X Slope (%)	N/A
N/A	Painted X Walk1?	No	N/A	Painted X Walk2?	No
	X Walk 1 Direction	To SW		X Walk 2 Direction	To SE
N/A	X Walk 1 Width (in)	N/A	N/A	X Walk 2 Width (in)	N/A
	X Walk 1 Slope (%)	1.3		X Walk 2 Slope (%)	2.3
	X Walk 1 X Slope (%)	1.8		X Walk 2 X Slope (%)	0.7

N/A	Ramp inside XWalk1?	N/A	N/A	Ramp inside XWalk2?	N/A
	Road Slope (%)	0.6	N/A	Clear Space?	N/A
	Road X Slope (%)	1.3	N/A	Clear Space to XWalk (in)	N/A
N/A	Any Obstructions?	N/A	N/A	Storm Grate/Utility Hazard?	N/A
	Obstruction Type			Storm Grate/Utility Type	
		N/A			N/A
			Yes	Surface Condition? (G/P)	Good

Remove & Replace Curb Ramp With Two New Directional Ramps or Equivalent.

Total Cost: \$ 3200.00
