# Access Compliance Report

## Public Rights-of-Way

### (Curb Ramps)

| Intersection ID: 13784 | Main Street: MORNINGSIDE_DR | Cross Street: IVEY_DR | Location: SE |

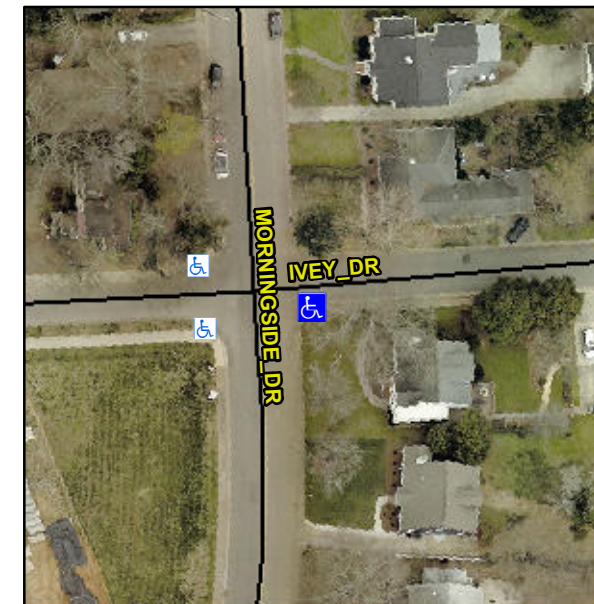
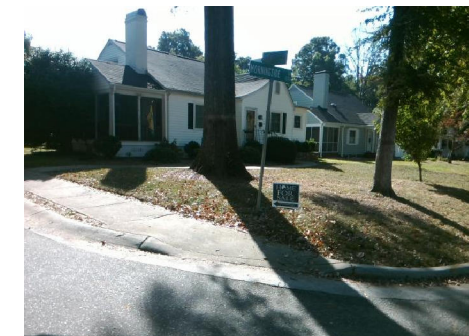
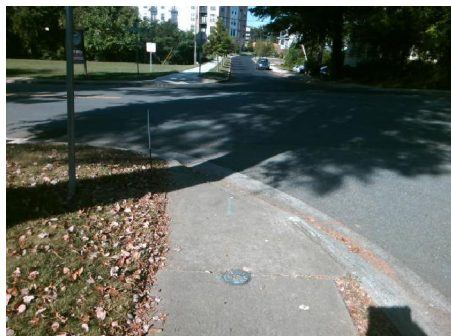
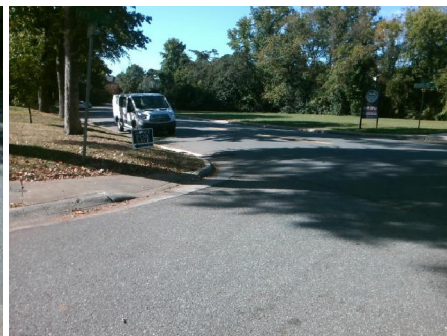
| ADA ID: E66C624BD2CB | Ramp Type: Perp | Initial Pass/Fail: Fail | Overall Compliance: No |

**Not Found, R304.2.2, R304.5.3**

| Compliance | Description | Data | Compliance | Description | Data |
|---|---|---|---|---|---|
| N/A | Ramp Length (in) | 26.0 | No | Ramp Slope (%) | 11.4 |
| Yes | Ramp Width (in) | 70.0 | No | Ramp XSlope (%) | 6.0 |

Possible Solutions:

**Remove & Replace Entire Ramp.**

Total Cost: \$ 1850.00
