# Access Compliance Report

## Public Rights-of-Way

### (Curb Ramps)

Intersection ID: 23309	Main Street: BRIDGEWOOD_LN	Cross Street: CARMEL_RD	Location:	N
ADA ID: E670CE747031	Ramp Type: PerpDiag	Initial Pass/Fail: Fail	Overall Compliance: No	Severity Score: 22.5

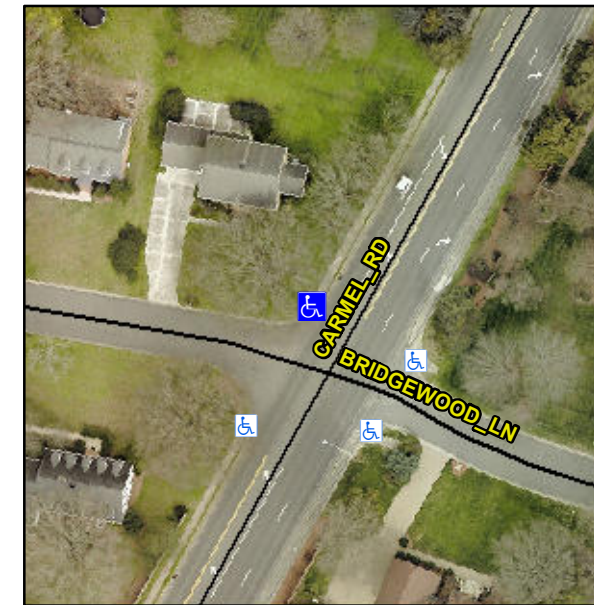
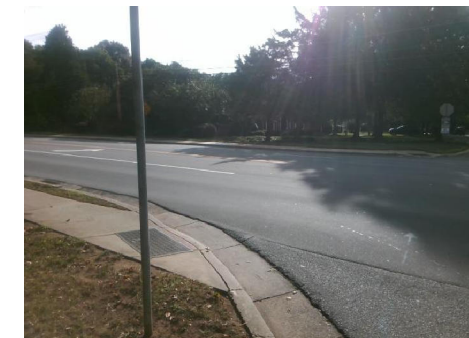
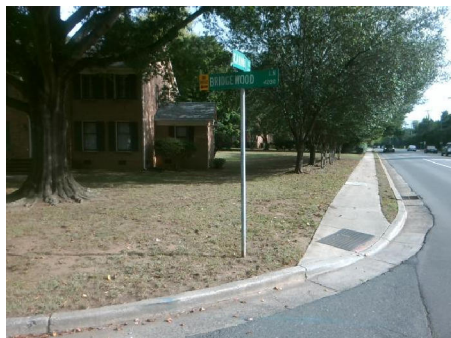
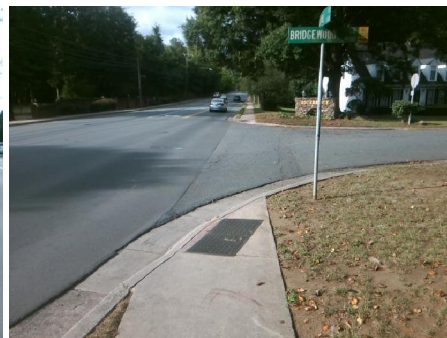
**Not Found, R304.5.1, R304.2.2, R304.5.3**

Compliance	Description	Data	Compliance	Description	Data
N/A	Ramp Length (in)	32.0	No	Ramp Slope (%)	11.3
No	Ramp Width (in)	40.0	No	Ramp XSlope (%)	3.1
N/A	Flare Type LT	N/A	N/A	Flare Type RT	N/A
N/A	Flare Slope LT (%)	N/A	N/A	Flare Slope RT (%)	N/A
N/A	Flare Traversable LT?	N/A	N/A	Flare Traversable RT?	N/A
N/A	Landing Length (in)	N/A	N/A	DWS Provided?	N/A
N/A	Landing Width (in)	N/A	N/A	DWS Contrast?	N/A
N/A	Landing Slope (%)	N/A	N/A	DWS Length (in)	N/A
N/A	Landing X Slope (%)	N/A	N/A	DWS Full Width?	N/A
N/A	Landing Curb? (Y/N)	N/A	N/A	DWS Offset (in)	N/A
N/A	Shared Landing?	N/A			
N/A	Gutter Ponding?	N/A	N/A	Gutter Slope (%)	N/A
N/A	Gutter Lip Ht (in)	N/A	N/A	Gutter X Slope (%)	N/A
N/A	Painted X Walk1?	No	N/A	Painted X Walk2?	No
	X Walk 1 Direction	To SW		X Walk 2 Direction	To SE
N/A	X Walk 1 Width (in)	N/A	N/A	X Walk 2 Width (in)	N/A
	X Walk 1 Slope (%)	1.9		X Walk 2 Slope (%)	5.7
	X Walk 1 X Slope (%)	4.5		X Walk 2 X Slope (%)	0.8

N/A	Ramp inside XWalk1?	N/A	N/A	Ramp inside XWalk2?	N/A
	Road Slope (%)	1.9	N/A	Clear Space?	N/A
	Road X Slope (%)	4.8	N/A	Clear Space to XWalk (in)	N/A
N/A	Any Obstructions?	N/A	N/A	Storm Grate/Utility Hazard?	N/A
	Obstruction Type			Storm Grate/Utility Type	
		N/A			N/A
			Yes	Surface Condition? (G/P)	Good

**Remove & Replace Curb Ramp With Two New Directional Ramps or Equivalent.**
