# Access Compliance Report

## Public Rights-of-Way

### (Curb Ramps)

Intersection ID: 27418	Main Street: BALLANTYNE COMMONS PY	Cross Street: BALLANTYNE TRACE CT	Location: SE
ADA ID: E672DD47D747	Ramp Type: Perp	Initial Pass/Fail: Fail	Overall Compliance: No
Severity Score: 22.5			
Codes/Mitigation Info/Possible Solution		Field Measurements/Component Compliance

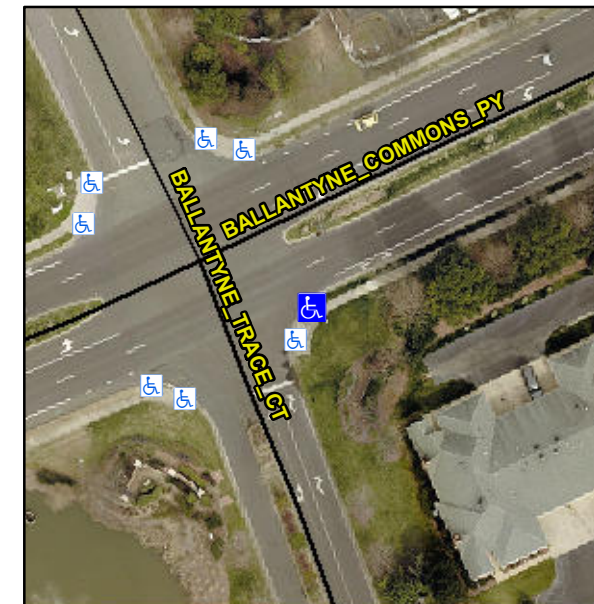
**Not Found, R304.5.1, R304.2.2**

Compliance	Description	Data	Compliance	Description	Data
N/A	Ramp Length (in)	107.0	No	Ramp Slope (%)	9.9
No	Ramp Width (in)	37.0	Yes	Ramp XSlope (%)	3.6
N/A	Flare Type LT	N/A	N/A	Flare Type RT	N/A
N/A	Flare Slope LT (%)	N/A	N/A	Flare Slope RT (%)	N/A
N/A	Flare Traversable LT?	N/A	N/A	Flare Traversable RT?	N/A
N/A	Landing Length (in)	N/A	N/A	DWS Provided?	N/A
N/A	Landing Width (in)	N/A	N/A	DWS Contrast?	N/A
N/A	Landing Slope (%)	N/A	N/A	DWS Length (in)	N/A
N/A	Landing X Slope (%)	N/A	N/A	DWS Full Width?	N/A
N/A	Landing Curb? (Y/N)	N/A	N/A	DWS Offset (in)	N/A
N/A	Shared Landing?	N/A			
N/A	Gutter Ponding?	N/A	N/A	Gutter Slope (%)	N/A
N/A	Gutter Lip Ht (in)	N/A	N/A	Gutter X Slope (%)	N/A
N/A	Painted X Walk1?	No	N/A	Painted X Walk2?	N/A
	X Walk 1 Direction	To N		X Walk 2 Direction	N/A
N/A	X Walk 1 Width (in)	N/A	N/A	X Walk 2 Width (in)	N/A
	X Walk 1 Slope (%)	0.6		X Walk 2 Slope (%)	N/A
	X Walk 1 X Slope (%)	4.6		X Walk 2 X Slope (%)	N/A

N/A	Ramp inside XWalk1?	N/A	N/A	Ramp inside XWalk2?	N/A
	Road Slope (%)	N/A	N/A	Clear Space?	N/A
	Road X Slope (%)	N/A	N/A	Clear Space to XWalk (in)	N/A
N/A	Any Obstructions?	N/A	N/A	Storm Grate/Utility Hazard?	N/A
	Obstruction Type			Storm Grate/Utility Type	
		N/A			N/A
			Yes	Surface Condition? (G/P)	Good

**Remove & Replace Entire Ramp.**

Total Cost: \$ 1850.00
