# Access Compliance Report

## Public Rights-of-Way

### (Curb Ramps)

Intersection ID: 4263	Main Street: DAVIS_LAKE_PY	Cross Street: SNOWS_ENTRY_PL	Location: S
ADA ID: E685082991B9	Ramp Type: Perp	Initial Pass/Fail: Fail	Overall Compliance: No
Severity Score: 46.25			
Codes/Mitigation Info/Possible Solution		Field Measurements/Component Compliance

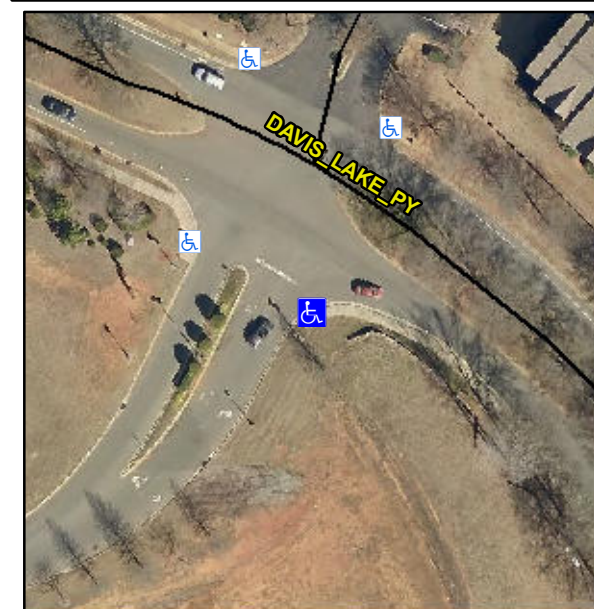
**R304.5.1, R304.2.2, R304.5.3**

Compliance	Description	Data	Compliance	Description	Data
N/A	Ramp Length (in)	60.0	No	Ramp Slope (%)	9.8
No	Ramp Width (in)	47.0	No	Ramp XSlope (%)	12.4
N/A	Flare Type LT	N/A	N/A	Flare Type RT	N/A
N/A	Flare Slope LT (%)	N/A	N/A	Flare Slope RT (%)	N/A
N/A	Flare Traversable LT?	N/A	N/A	Flare Traversable RT?	N/A
N/A	Landing Length (in)	N/A	N/A	DWS Provided?	N/A
N/A	Landing Width (in)	N/A	N/A	DWS Contrast?	N/A
N/A	Landing Slope (%)	N/A	N/A	DWS Length (in)	N/A
N/A	Landing X Slope (%)	N/A	N/A	DWS Full Width?	N/A
N/A	Landing Curb? (Y/N)	N/A	N/A	DWS Offset (in)	N/A
N/A	Shared Landing?	N/A			
N/A	Gutter Ponding?	N/A	N/A	Gutter Slope (%)	N/A
N/A	Gutter Lip Ht (in)	N/A	N/A	Gutter X Slope (%)	N/A
N/A	Painted X Walk1?	No	N/A	Painted X Walk2?	N/A
	X Walk 1 Direction	To NW		X Walk 2 Direction	N/A
N/A	X Walk 1 Width (in)	N/A	N/A	X Walk 2 Width (in)	N/A
	X Walk 1 Slope (%)	3.0		X Walk 2 Slope (%)	N/A
	X Walk 1 X Slope (%)	10.4		X Walk 2 X Slope (%)	N/A

N/A	Ramp inside XWalk1?	N/A	N/A	Ramp inside XWalk2?	N/A
	Road Slope (%)	N/A	N/A	Clear Space?	N/A
	Road X Slope (%)	N/A	N/A	Clear Space to XWalk (in)	N/A
N/A	Any Obstructions?	N/A	N/A	Storm Grate/Utility Hazard?	N/A
	Obstruction Type			Storm Grate/Utility Type	
		N/A			N/A
			Yes	Surface Condition? (G/P)	Good

**Remove & Replace Entire Ramp.**

Total Cost: \$ 1850.00
