Access Compliance Report

Public Rights-of-Way

(Curb Ramps)

Intersection ID: 10629	Main Street: FLINT_ST	Cross Street: MARTIN_ST	Location:	E
ADA ID: E688AA59C4E3	Ramp Type: Perp	Initial Pass/Fail: Fail	Overall Compliance: No	Severity Score: 10

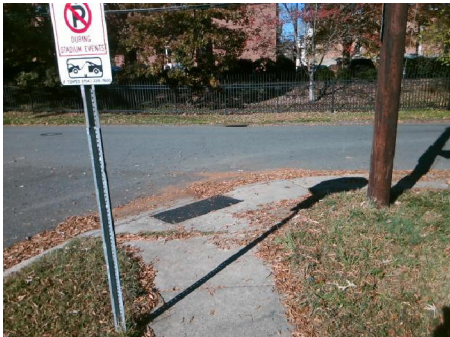
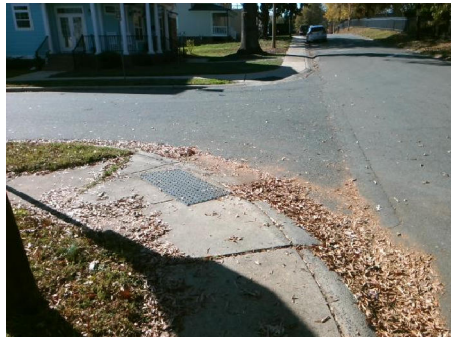
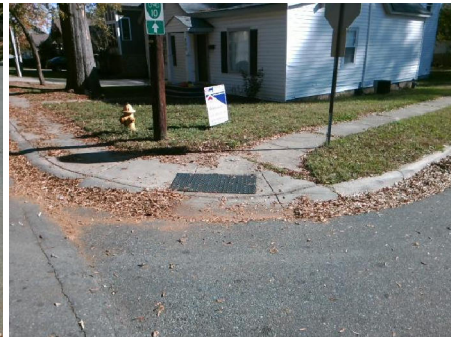
Possible Solutions:		Compliance	Description	Data
	Remove & Replace Entire Ramp.		N/A	Ramp Length (in)	48.0
			No	Ramp Width (in)	40.5
			N/A	Flare Type LT	N/A
			N/A	Flare Slope LT (%)	N/A
			N/A	Flare Traversable LT?	N/A
			N/A	Landing Length (in)	N/A
			N/A	Landing Width (in)	N/A
			N/A	Landing Slope (%)	N/A
			N/A	Landing X Slope (%)	N/A
<p>Surveyor Notes:</p> <p>N/A</p> <p>PROW/ADA:</p> <p>Not Found, R304.5.1, R304.5.3</p>			N/A	Flare Type RT	N/A
			N/A	Flare Slope RT (%)	N/A
			N/A	Flare Traversable RT?	N/A
			N/A	DWS Provided?	N/A
			N/A	DWS Contrast?	N/A
			N/A	DWS Length (in)	N/A
			N/A	DWS Full Width?	N/A
			N/A	DWS Offset (in)	N/A
			N/A	Gutter Ponding?	N/A
			N/A	Gutter Lip Ht (in)	N/A
<p>Total Cost:</p> <p>\$ 1850.00</p>			No	Painted X Walk1?	N/A
				X Walk 1 Direction	To W
			N/A	X Walk 1 Width (in)	N/A
				X Walk 1 Slope (%)	4.5

X Walk 1 X Slope (%)	5.0
			N/A	Ramp inside XWalk1?	N/A
			N/A	Road Slope (%)	N/A
			N/A	Road X Slope (%)	N/A
			N/A	Any Obstructions?	N/A
				Obstruction Type	
			N/A	Clear Space?	N/A
			N/A	Clear Space to XWalk (in)	N/A
			N/A	Storm Grate/Utility Hazard?	N/A
				Storm Grate/Utility Type	
			N/A		N/A
			Yes	Surface Condition? (G/P)	Good
