# Access Compliance Report

## Public Rights-of-Way (Curb Ramps)

Intersection ID: 3399	Main Street: BUTTON_POINTE_CT	Cross Street: PRESERVATION_POINTE_DR	Location: NW
ADA ID: E69254AB3518	Ramp Type: Perp	Initial Pass/Fail: Fail	Overall Compliance: No Severity Score: 33.75

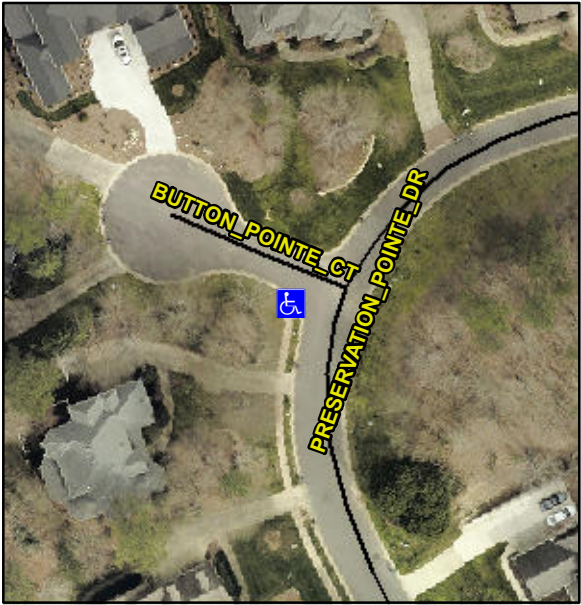
Possible Solutions:		<b>Compliance</b>	<b>Description</b>	<b>Data</b>
	<b>Remove &amp; Replace Entire Ramp.</b>		<b>No</b>	Ramp Length (in)	<b>95.0</b>
			<b>No</b>	Ramp Width (in)	<b>47.5</b>
			<b>N/A</b>	Flare Type LT	<b>N/A</b>
			<b>N/A</b>	Flare Slope LT (%)	<b>N/A</b>
			<b>N/A</b>	Flare Traversable LT?	<b>N/A</b>
			<b>N/A</b>	Landing Length (in)	<b>N/A</b>
			<b>N/A</b>	Landing Width (in)	<b>N/A</b>
			<b>N/A</b>	Landing Slope (%)	<b>N/A</b>
			<b>N/A</b>	Landing X Slope (%)	<b>N/A</b>
<p>Surveyor Notes:</p> <p><b>N/A</b></p> <p>PROW/ADA:</p> <p><b>Not Found, R304.5.1, R304.2.2, R304.5.3</b></p>			<b>N/A</b>	Flare Type RT	<b>N/A</b>
			<b>N/A</b>	Flare Slope RT (%)	<b>N/A</b>
			<b>N/A</b>	Flare Traversable RT?	<b>N/A</b>
			<b>N/A</b>	DWS Provided?	<b>N/A</b>
			<b>N/A</b>	DWS Contrast?	<b>N/A</b>
			<b>N/A</b>	DWS Length (in)	<b>N/A</b>

<b>N/A</b>	DWS Full Width?	<b>N/A</b>
			<b>N/A</b>	DWS Offset (in)	<b>N/A</b>
			<b>N/A</b>	Gutter Ponding?	<b>N/A</b>
			<b>N/A</b>	Gutter Lip Ht (in)	<b>N/A</b>
<p>Total Cost:</p> <p><b>\$ 1850.00</b></p>			<b>No</b>	Painted X Walk1?	<b>N/A</b>
			<b>To N</b>	X Walk 2 Direction	<b>N/A</b>
			<b>N/A</b>	X Walk 2 Width (in)	<b>N/A</b>
			<b>3.4</b>	X Walk 2 Slope (%)	<b>N/A</b>
			<b>3.8</b>	X Walk 2 X Slope (%)	<b>N/A</b>
			<b>N/A</b>	Ramp inside XWalk2?	<b>N/A</b>
			<b>3.8</b>	Clear Space?	<b>N/A</b>
			<b>3.4</b>	Clear Space to XWalk (in)	<b>N/A</b>
			<b>N/A</b>	Storm Grate/Utility Hazard?	<b>N/A</b>
			<b>N/A</b>	Storm Grate/Utility Type	<b>N/A</b>
			<b>N/A</b>	Surface Condition? (G/P)	<b>Good</b>
