Access Compliance Report Public Rights-of-Way (Curb Ramps)

Intersection ID: 50611 Main Street: COTTON GUM RD Cross Street: DOWNY BIRCH RD Location: SE **Overall Compliance: No Severity Score:** 10 **ADA ID: E6A0EB60068F** Ramp Type: Perp Initial Pass/Fail: Fail

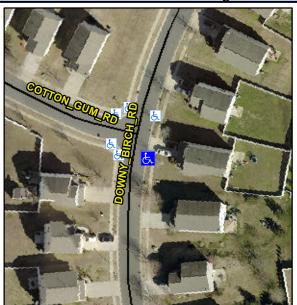
DOWNY BIRCH RD Street 1 Name Stop Condition-Street 2 None N/A Street 2 Name Stop Condition-Street 1 N/A Possible Solutions: Compliance Description N/A Remove & Replace Entire Ramp. No N/A N/A Surveyor Notes: N/A PROW/ADA: Not Found, R304.5.1
