Access Compliance Report Public Rights-of-Way (Curb Ramps)

Intersection ID: 47573 Main Street: SEDGEBURN DR **Cross Street: GAILES DR** Location: NW ADA ID: E6A77E7445A2 Initial Pass/Fail: Fail **Overall Compliance: No Severity Score:** Ramp Type: PerpDiag 8.75

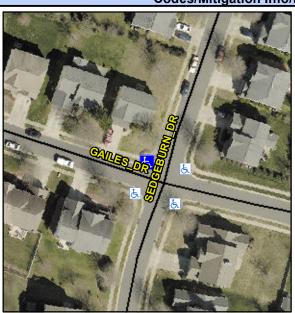
Compliance Description Data Compliance Description Data Yes N/A Ramp Length (in) 47.0 Ramp Slope (%) 7.0 Yes Ramp XSlope (%) No Ramp Width (in) 44.0 0.5 N/A N/A Flare Type LT N/A Flare Type RT N/A N/A N/A N/A Flare Slope RT (%) N/A Flare Slope LT (%) N/A Flare Traversable LT? N/A N/A Flare Traversable RT? N/A N/A N/A N/A **DWS Provided?** N/A Landing Length (in) N/A Landing Width (in) N/A N/A **DWS Contrast?** N/A N/A N/A N/A Landing Slope (%) DWS Length (in) N/A N/A Landing X Slope (%) N/A N/A DWS Full Width? N/A N/A Landing Curb? (Y/N) N/A N/A DWS Offset (in) N/A N/A N/A Shared Landing? N/A **Gutter Ponding?** N/A N/A Gutter Slope (%) N/A N/A Gutter Lip Ht (in) N/A N/A Gutter X Slope (%) N/A N/A Painted X Walk1? No N/A Painted X Walk2? No X Walk 1 Direction To SW X Walk 2 Direction To SE N/A N/A X Walk 2 Width (in) N/A X Walk 1 Width (in) X Walk 1 Slope (%) 0.9 X Walk 2 Slope (%) 3.3 X Walk 1 X Slope (%) 1.6 X Walk 2 X Slope (%) 2.5 N/A N/A N/A Ramp inside XWalk2? N/A Ramp inside XWalk1? Road Slope (%) 1.0 N/A Clear Space? N/A N/A Road X Slope (%) 4.9 Clear Space to XWalk (in) N/A N/A N/A N/A Any Obstructions? Storm Grate/Utility Hazard? N/A **Obstruction Type** Storm Grate/Utility Type N/A N/A Yes Surface Condition? (G/P) Good

GAILES DR Street 1 Name Stop Condition-Street 2 None **SEDGEBURN DR** Street 2 Name Stop Condition-Street 1 StopSign Possible Solutions: Remove & Replace Curb Ramp With Two New Directional Ramps or Equivalent. Surveyor Notes: N/A PROW/ADA: R304.5.1
