# Access Compliance Report

## Public Rights-of-Way

| Intersection ID: 30067 | Main Street: OHAUS_CT | Cross Street: WATERS_TRAIL_DR | Location: NE |
| ADA ID: E6AC10E51341 | Ramp Type: PerpDiag | Initial Pass/Fail: Fail | Overall Compliance: No |

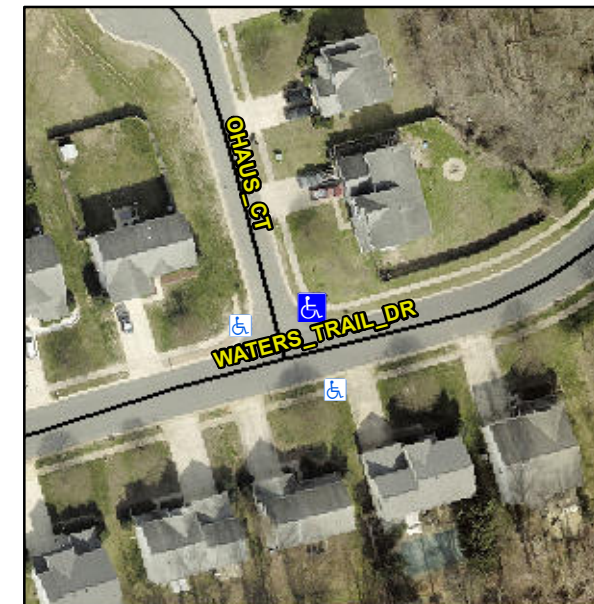
| | | Severity Score: 12.5 | |

**Not Found, R304.5.3**

| Compliance | Description | Data | Compliance | Description | Data |
|---|---|---|---|---|---|
| Yes | Ramp Width (in) | 48.0 | No | Ramp XSlope (%) | 5.1 |

**Remove & Replace Curb Ramp With Two New Directional Ramps or Equivalent.**
