## Access Compliance Report Public Rights-of-Way (Curb Ramps)

-	-	-					
Intersection ID: 29147	Main Street: BALSAM_TREE_DR			Street:	WALLACE_RIDGE_DR	Location:	SW		
ADA ID: E6B78EC809C2	Ramp Type: PerpDiag			Initial Pass/Fail: Fail Overall Compliance: No				o Severity Score:	10
Codes/Mitigation Info/Possible Solution				Field Measurements/Component Compliance					
		Possible Solutions:		Compliance Description		Data Compliance Description		Data	
		Remove & Replace Curb Ramp V	Vith	N/A	Ramp Length (in)	64.0	Yes	Ramp Slope (%)	5.5
		Two New Directional Ramps or	-	No	Ramp Width (in)	44.0	No	Ramp XSlope (%)	3.7
A CONTRACTOR		Equivalent.		N/A	Flare Type LT	N/A	N/A	Flare Type RT	N/A
	A CALIN			N/A	Flare Slope LT (%)	N/A	N/A	Flare Slope RT (%)	N/A
				N/A	Flare Traversable LT?	N/A	N/A	Flare Traversable RT?	N/A
EM com	the second secon			N/A	Landing Length (in)	N/A	N/A	DWS Provided?	N/A
BALSAM_TR		Surveyor Notes:		N/A	Landing Width (in)	N/A	N/A	DWS Contrast?	N/A
		N/A		N/A	Landing Slope (%)	N/A	N/A	DWS Length (in)	N/A

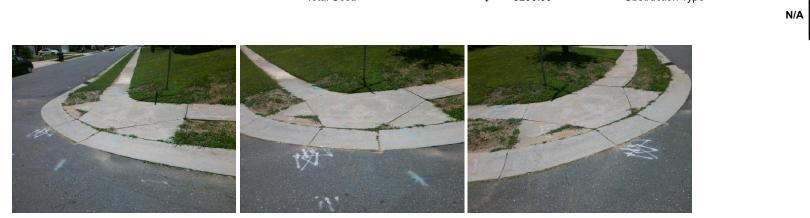
N/A	Landing X Slope (%)	N/A	N/A	DWS Full Width?	N/A
				N/A	Landing Curb? (Y/N)	N/A	N/A	DWS Offset (in)	N/A
		4		N/A	Shared Landing?	N/A			
		PROW/ADA:		N/A	Gutter Ponding?	N/A	N/A	Gutter Slope (%)	N/A
	1 s America	Not Found, R304.5.1, R304.5.3		N/A	Gutter Lip Ht (in)	N/A	N/A	Gutter X Slope (%)	N/A
				N/A	Painted X Walk1?	No	N/A	Painted X Walk2?	No
WHEN THE BELLEVILLE	A Paul				X Walk 1 Direction	To N		X Walk 2 Direction	To E
	1 Tatter to			N/A	X Walk 1 Width (in)	N/A	N/A	X Walk 2 Width (in)	N/A
Street 1 Name	BALSAM TREE DR				X Walk 1 Slope (%)	5.3		X Walk 2 Slope (%)	0.9
Stop Condition-Street 2	StopSign				X Walk 1 X Slope (%)	2.1		X Walk 2 X Slope (%)	3.3
Street 2 Name	WALLACE RIDGE DR			N/A	Ramp inside XWalk1?	N/A	N/A	Ramp inside XWalk2?	N/A
Stop Condition-Street 1	None				Road Slope (%)	4.1	N/A	Clear Space?	N/A
					Road X Slope (%)	0.4	N/A	Clear Space to XWalk (in)	N/A
				N/A	Any Obstructions?	0.4 N/A	N/A	Storm Grate/Utility Hazard?	N/A

Total Cost: \$ 3	200.00		Obstruction Type			Storm Grate/Utility Type	
		····· ••••				N/A			N/A
						104	1		10/5
