## Access Compliance Report Public Rights-of-Way (Curb Ramps)

Intersection ID: 11686Main Street:BRISTOL\_DRCross Street:CARLYLE\_DRLocation:NWADA ID: E6B7D831FEDBRamp Type:BlendTrans2Initial Pass/Fail:FailOverall Compliance:NoSeverity Score:1.25

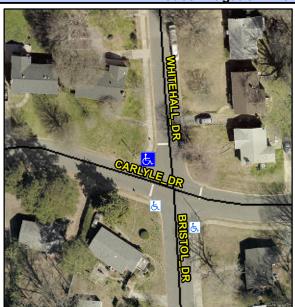
Field Measurements/Component Compliance					
Compliance Description		Data	Compliance Description		Data
N/A	Ramp Length (in)	85.0	Yes	BlendTrans Slope (%)	2.1
Yes	Ramp Width (in)	48.0	No	BlendTrans XSlope (%)	3.4
N/A	Flare Type LT	N/A	N/A	Flare Type RT	N/A
N/A	Flare Slope LT (%)	N/A	N/A	Flare Slope RT (%)	N/A
N/A	Flare Traversable LT?	N/A	N/A	Flare Traversable RT?	N/A
N/A	Landing Length (in)	N/A	N/A	DWS Provided?	N/A
N/A	Landing Width (in)	N/A	N/A	DWS Contrast?	N/A
N/A	Landing Slope (%)	N/A	N/A	DWS Length (in)	N/A
N/A	Landing X Slope (%)	N/A	N/A	DWS Full Width?	N/A
N/A	Landing Curb? (Y/N)	N/A	N/A	DWS Offset (in)	N/A
N/A	Shared Landing?	N/A			
N/A	Gutter Ponding?	N/A	N/A	Gutter Slope (%)	N/A
N/A	Gutter Lip Ht (in)	N/A	N/A	Gutter X Slope (%)	N/A
N/A	Painted X Walk1?	No	N/A	Painted X Walk2?	N/A
	X Walk 1 Direction	To S		X Walk 2 Direction	N/A
	X Walk 1 Width (in)	N/A		X Walk 2 Width (in)	N/A
	X Walk 1 Slope (%)	1.7		X Walk 2 Slope (%)	N/A

X Walk 1 X Slope (%)	0.7		X Walk 2 X Slope (%)	N/A
N/A	Ramp inside XWalk1?	N/A	N/A	Ramp inside XWalk2?	N/A
	Road Slope (%)	0.7		Clear Space?	N/A
	Road X Slope (%)	1.7	N/A	Clear Space to XWalk (in)	N/A
N/A	Any Obstructions?	N/A	N/A	Storm Grate/Utility Hazard?	N/A
	Obstruction Type			Storm Grate/Utility Type	
		N/A			N/A
			Yes	Surface Condition? (G/P)	Good
			No	Curb Slope (%)	26.1
THE PARTY NAMED IN	A STATE OF THE STA

Remove & Replace Curb Ramp With
Two New Directional Ramps or
Equivalent.

PROW/ADA:
Not Found, R304.5.3
