# Access Compliance Report

## Public Rights-of-Way

### (Curb Ramps)

| Intersection ID: 10477 | Main Street: HAMILTON_ST | Cross Street: POLK_ST | Location: | N |

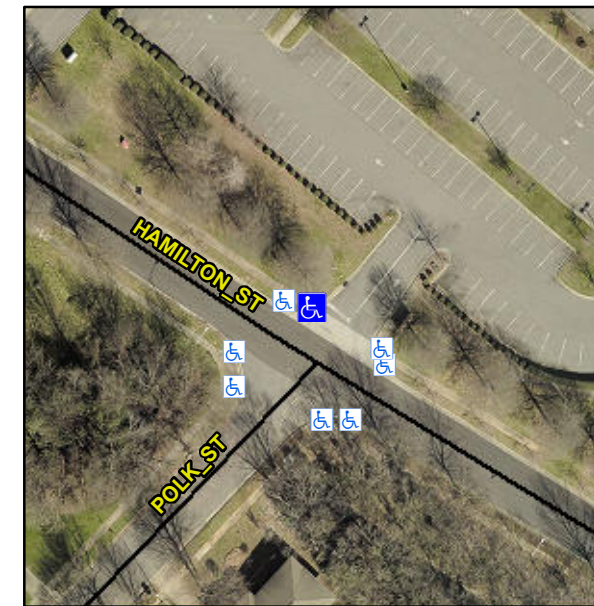
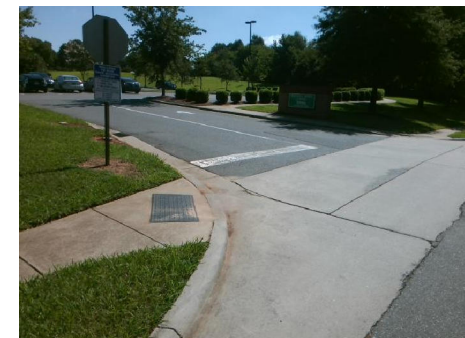
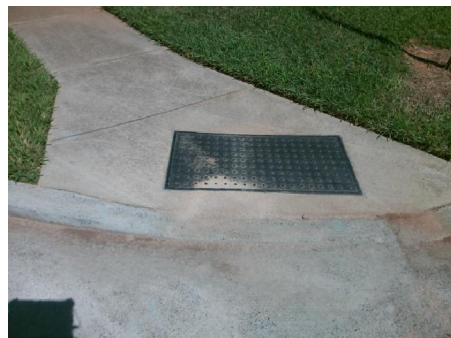
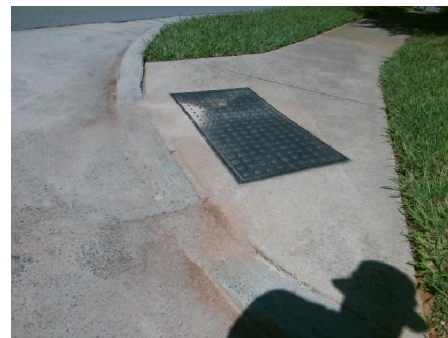
| ADA ID: E6BE806F10C0 | Ramp Type: BlendTrans1 | Initial Pass/Fail: Pass | Overall Compliance: No | Severity Score: 10 |

**Not Found, R304.2.1, R305.1.4, R305.2, R302.7, R302.7.2**

| Compliance | Description | Data | Compliance | Description | Data |
|---|---|---|---|---|---|
| No | Landing Length (in) | 45.0 | Yes | DWS Provided? | Yes |
| Yes | Landing X Slope (%) | 1.1 | No | DWS Full Width? | No |
| N/A | Landing Curb? (Y/N) | No | No | DWS Offset (in) | 9.0 |
| No | Gutter Ponding? | Yes | Yes | Gutter Slope (%) | 4.8 |
| No | Gutter Lip Ht (in) | 0.5 | Yes | Gutter X Slope (%) | 0.4 |
| | | | No | Curb Slope (%) | 21.9 |

**Remove & Replace Curb Ramp With Two New Directional Ramps or Equivalent.**
