# Access Compliance Report

## Public Rights-of-Way

### (Curb Ramps)

| Intersection ID: 27755 | Main Street: BALLANTYNE_CROSSING_AV | Cross Street: NOLEN_LN | Location: N |

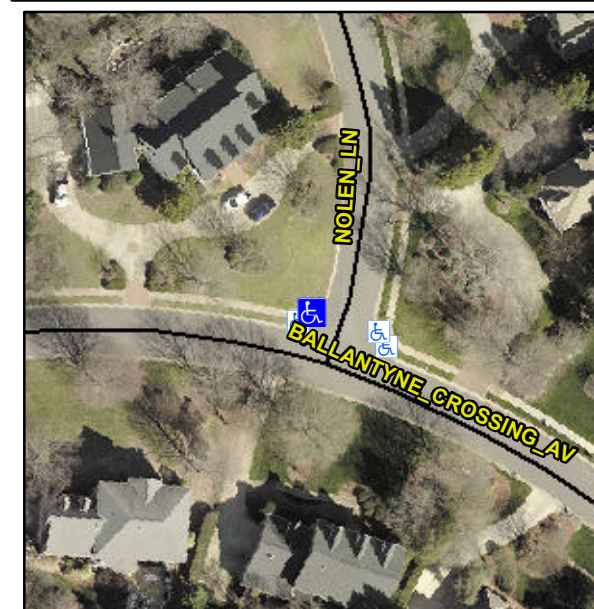
| ADA ID: E6C0FF26D5BF | Ramp Type: Perp | Initial Pass/Fail: Fail | Overall Compliance: No |
| Severity Score: 58.75 | | | |

**Not Found, R304.5.1, R304.2.2, R304.5.3**

| Compliance | Description | Data | Compliance | Description | Data |
|---|---|---|---|---|---|
| N/A | Ramp Length (in) | 47.0 | No | Ramp Slope (%) | 13.7 |
| No | Ramp Width (in) | 46.0 | No | Ramp XSlope (%) | 11.8 |

**Remove & Replace Entire Ramp.**

Total Cost: \$ 1850.00
