Access Compliance Report

Public Rights-of-Way

(Curb Ramps)

Intersection ID: 49126	Main Street: CARLOTA_CT	Cross Street: LEGOLAS_LN	Location: NE
ADA ID: E6DDF78336AE	Ramp Type: PerpDiag	Initial Pass/Fail: Fail	Overall Compliance: No
Severity Score: 58.75			
Codes/Mitigation Info/Possible Solution		Field Measurements/Component Compliance

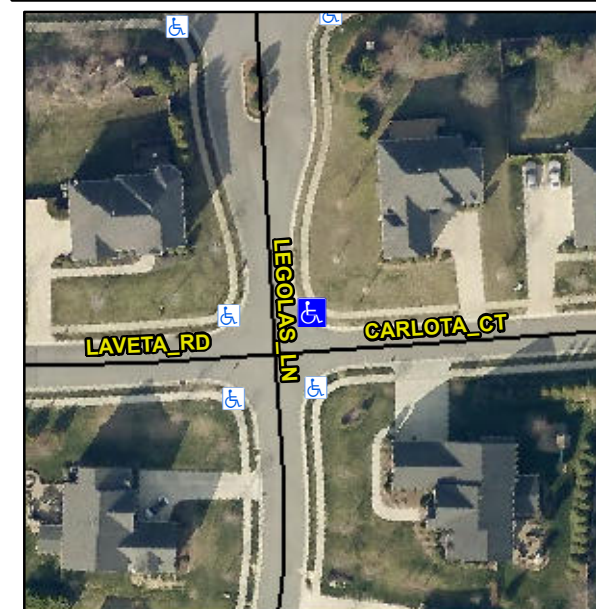
Not Found, R304.5.1, R304.2.2, R304.5.3

Compliance	Description	Data	Compliance	Description	Data
N/A	Ramp Length (in)	48.0	No	Ramp Slope (%)	12.3
No	Ramp Width (in)	37.0	No	Ramp XSlope (%)	7.2
N/A	Flare Type LT	N/A	N/A	Flare Type RT	N/A
N/A	Flare Slope LT (%)	N/A	N/A	Flare Slope RT (%)	N/A
N/A	Flare Traversable LT?	N/A	N/A	Flare Traversable RT?	N/A
N/A	Landing Length (in)	N/A	N/A	DWS Provided?	N/A
N/A	Landing Width (in)	N/A	N/A	DWS Contrast?	N/A
N/A	Landing Slope (%)	N/A	N/A	DWS Length (in)	N/A
N/A	Landing X Slope (%)	N/A	N/A	DWS Full Width?	N/A
N/A	Landing Curb? (Y/N)	N/A	N/A	DWS Offset (in)	N/A
N/A	Shared Landing?	N/A			
N/A	Gutter Ponding?	N/A	N/A	Gutter Slope (%)	N/A
N/A	Gutter Lip Ht (in)	N/A	N/A	Gutter X Slope (%)	N/A
N/A	Painted X Walk1?	No	N/A	Painted X Walk2?	No
	X Walk 1 Direction	To W		X Walk 2 Direction	To S
N/A	X Walk 1 Width (in)	N/A	N/A	X Walk 2 Width (in)	N/A
	X Walk 1 Slope (%)	5.0		X Walk 2 Slope (%)	0.3
	X Walk 1 X Slope (%)	2.3		X Walk 2 X Slope (%)	5.7

N/A	Ramp inside XWalk1?	N/A	N/A	Ramp inside XWalk2?	N/A
	Road Slope (%)	3.8	N/A	Clear Space?	N/A
	Road X Slope (%)	4.6	N/A	Clear Space to XWalk (in)	N/A
N/A	Any Obstructions?	N/A	N/A	Storm Grate/Utility Hazard?	N/A
	Obstruction Type			Storm Grate/Utility Type	
		N/A			N/A
			Yes	Surface Condition? (G/P)	Good

Possible Solutions:

Remove & Replace Curb Ramp With Two New Directional Ramps or Equivalent.
