Access Compliance Report

Public Rights-of-Way

(Curb Ramps)

Intersection ID: 24469	Main Street: MIROW_PL	Cross Street: SAINTFIELD_PL	Location: SE
ADA ID: E718A55D078F	Ramp Type: Perp	Initial Pass/Fail: Fail	Overall Compliance: No
Codes/Mitigation Info/Possible Solution			Severity Score: 25
			Field Measurements/Component Compliance

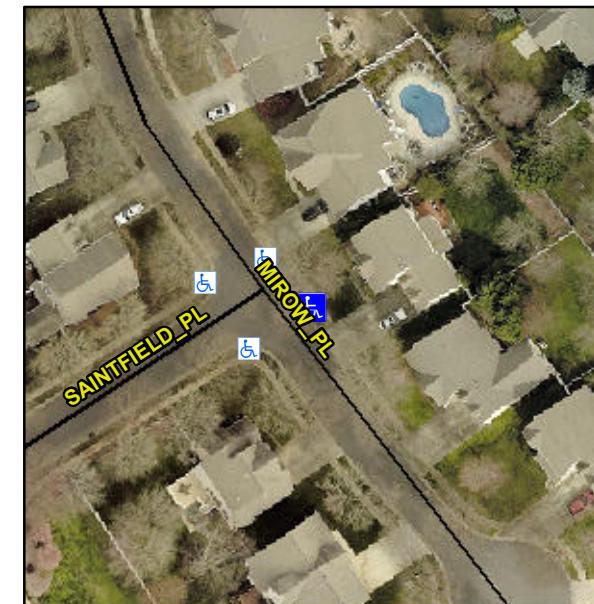
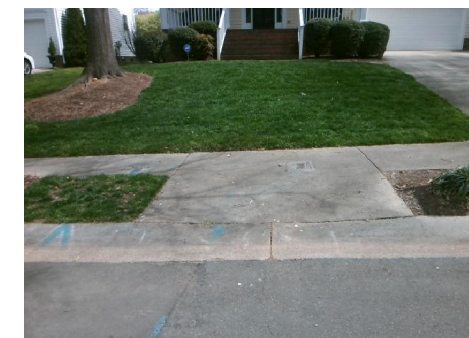
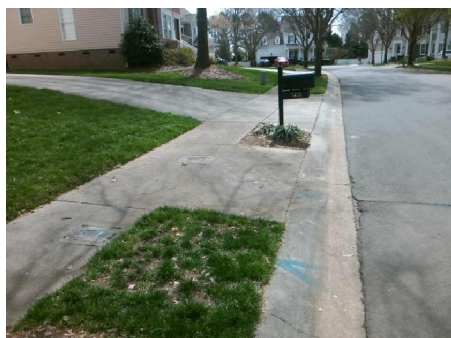
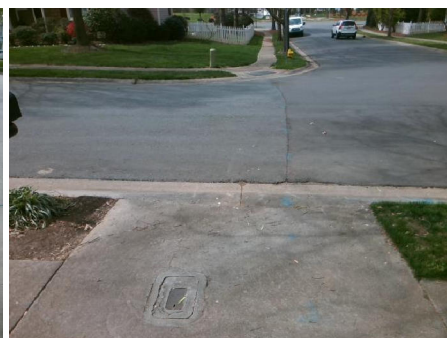
Not Found, R304.2.2, R304.5.3

Compliance	Description	Data	Compliance	Description	Data
N/A	Ramp Length (in)	46.0	No	Ramp Slope (%)	9.0
Yes	Ramp Width (in)	48.0	No	Ramp XSlope (%)	6.2
N/A	Flare Type LT	N/A	N/A	Flare Type RT	N/A
N/A	Flare Slope LT (%)	N/A	N/A	Flare Slope RT (%)	N/A
N/A	Flare Traversable LT?	N/A	N/A	Flare Traversable RT?	N/A
N/A	Landing Length (in)	N/A	N/A	DWS Provided?	N/A
N/A	Landing Width (in)	N/A	N/A	DWS Contrast?	N/A
N/A	Landing Slope (%)	N/A	N/A	DWS Length (in)	N/A
N/A	Landing X Slope (%)	N/A	N/A	DWS Full Width?	N/A
N/A	Landing Curb? (Y/N)	N/A	N/A	DWS Offset (in)	N/A
N/A	Shared Landing?	N/A			
N/A	Gutter Ponding?	N/A	N/A	Gutter Slope (%)	N/A
N/A	Gutter Lip Ht (in)	N/A	N/A	Gutter X Slope (%)	N/A
N/A	Painted X Walk1?	No	N/A	Painted X Walk2?	N/A
	X Walk 1 Direction	To W		X Walk 2 Direction	N/A
N/A	X Walk 1 Width (in)	N/A	N/A	X Walk 2 Width (in)	N/A
	X Walk 1 Slope (%)	2.1		X Walk 2 Slope (%)	N/A
	X Walk 1 X Slope (%)	4.1		X Walk 2 X Slope (%)	N/A

N/A	Ramp inside XWalk1?	N/A	N/A	Ramp inside XWalk2?	N/A
	Road Slope (%)	N/A	N/A	Clear Space?	N/A
	Road X Slope (%)	N/A	N/A	Clear Space to XWalk (in)	N/A
N/A	Any Obstructions?	N/A	N/A	Storm Grate/Utility Hazard?	N/A
	Obstruction Type			Storm Grate/Utility Type	
		N/A			N/A
			Yes	Surface Condition? (G/P)	Good

Remove & Replace Entire Ramp.
