Access Compliance Report Public Rights-of-Way (Curb Ramps)

Intersection ID: 22079 Main Street: LILLY MILL RD **Cross Street: TATTERSALL DR** Location:

Overall Compliance: No ADA ID: E7213018BCD2 Ramp Type: PerpDiag Initial Pass/Fail: Fail Severity Score: 13.75

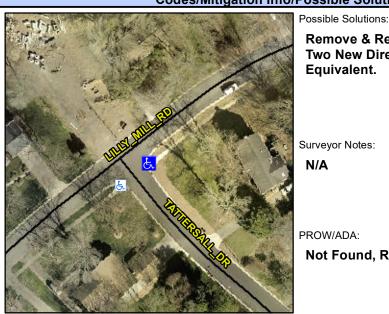
Not Found, R304.2.2, R304.5.3

X Walk 1 Slope (%) 3.9 X Walk 2 Slope (%) 5.7 X Walk 2 X Slope (%) X Walk 1 X Slope (%) 1.1 0.9 N/A N/A N/A Ramp inside XWalk2? N/A Ramp inside XWalk1? Road Slope (%) 0.6 N/A Clear Space? N/A N/A Road X Slope (%) Clear Space to XWalk (in) N/A 4.4 N/A N/A N/A Any Obstructions? Storm Grate/Utility Hazard? N/A **Obstruction Type** 3200.00 Storm Grate/Utility Type N/A N/A Yes Surface Condition? (G/P) Good

LILLY MILL RD None **TATTERSALL DR** StopSign Remove & Replace Curb Ramp With Two New Directional Ramps or Equivalent.
